The City of Maitland Library: Facilities Assessment Report

BORRELLI + PARTNERS

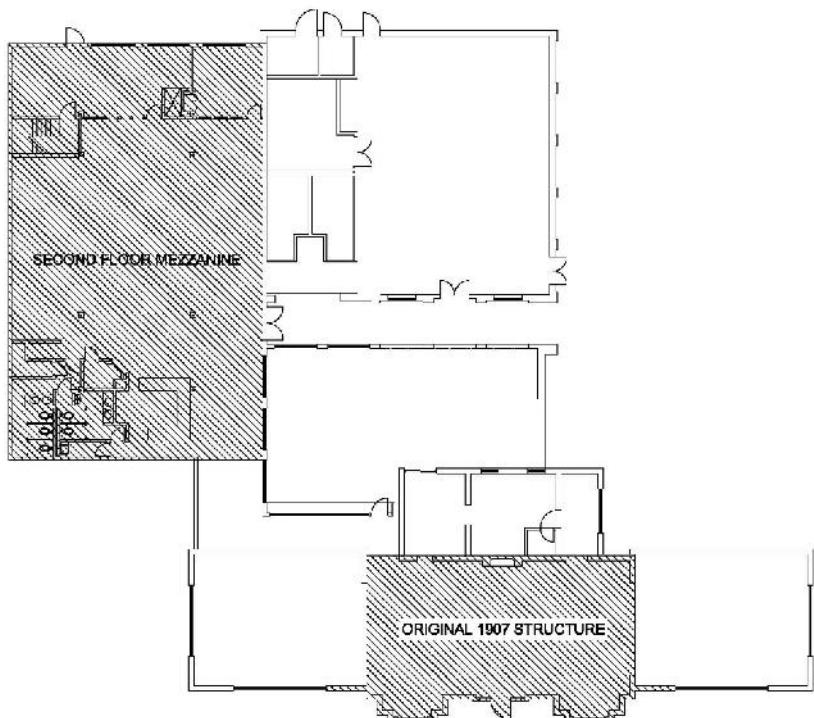
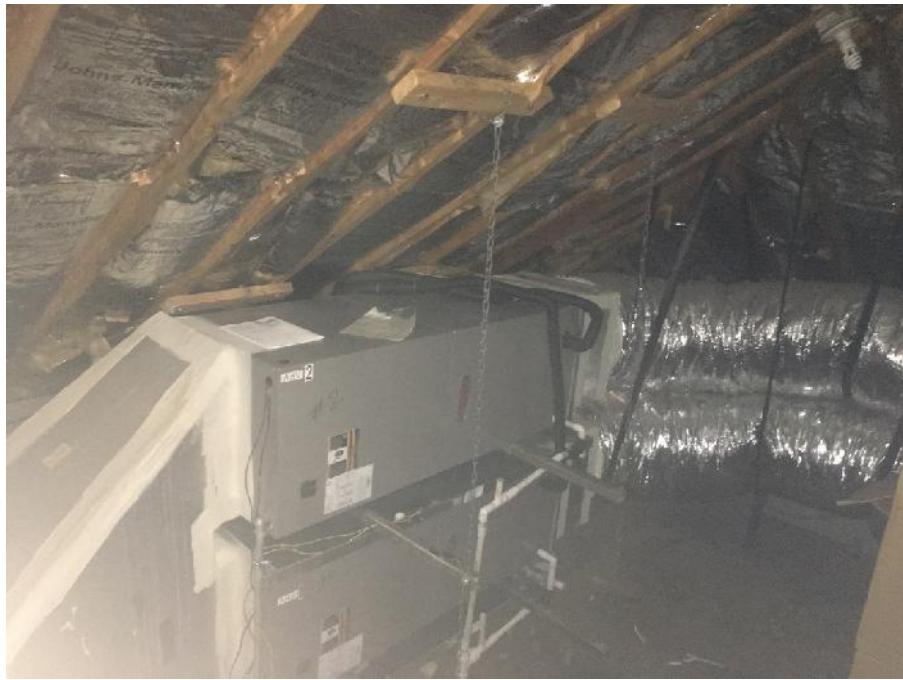
The one deficiency found included improper hangers used at the mezzanine mechanical units from suspending the hvac units and ducts from the mansard roof wood framing 2x10 rafters. The current hangers do not show a sign of distress however we cannot confirm the existing hangers' capacity and therefore adequacy should the existing hvac system be updated.

- _) Do not support hvac or other new units onto the mezzanine level mechanical room without first strengthening the second-floor framing in the space,
- _) Avoid removal or adjoining new structural elements onto the original 1907 building footprint, and
- _) Avoid additions such as transfer beams and build-up framing onto the existing roof rafters.

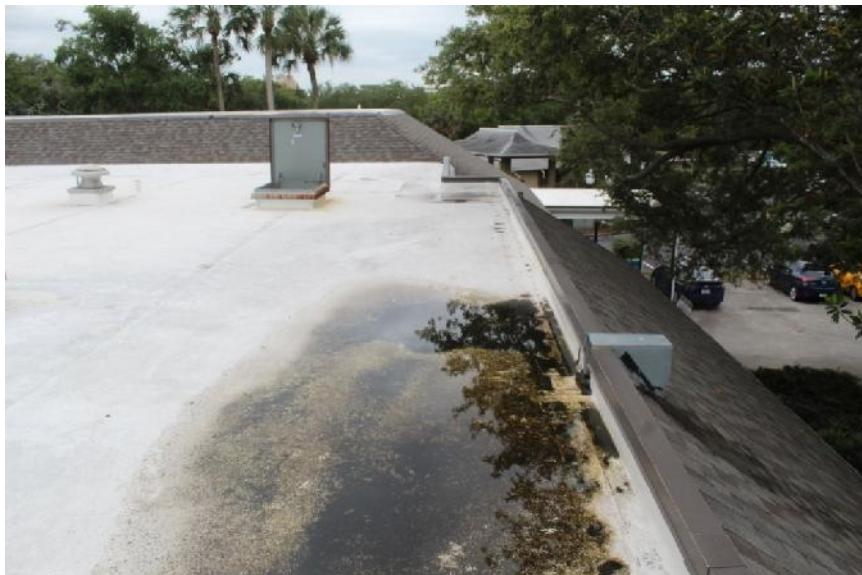
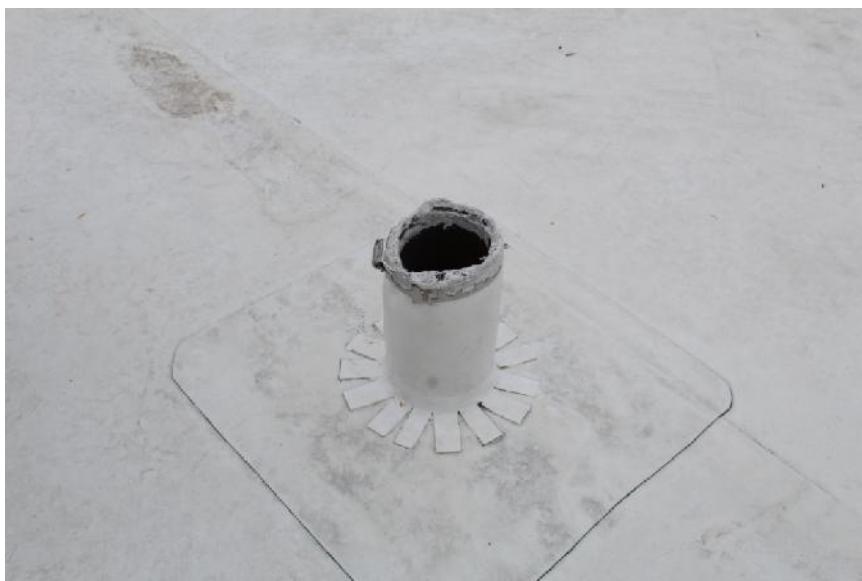
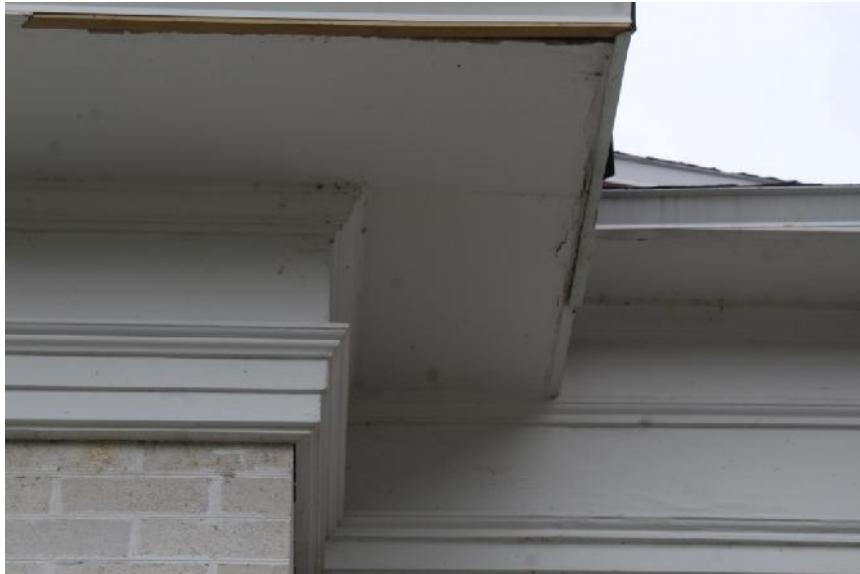
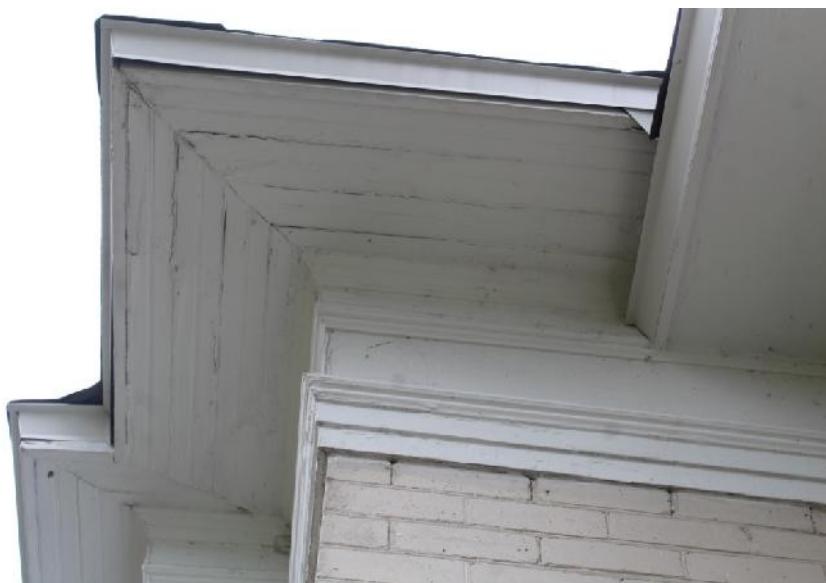
-]) The 3-tab asphalt shingle roofing systems appeared to be functioning as originally intended and in good condition.
-]) The low-sloped roofing membrane was observed to have ponding occurring around the scuppers. The roofs appear to be functioning as originally intended and in good condition, except for the following: one area was observed to have a puncture in the membrane, one improperly flashed pipe penetration and sealant deterioration.
-]) The soffit was in fair to poor condition with repairs and maintenance needing to be performed.

- o The collection of vegetation in the gutters does not allow for proper drainage.
- o The pipe penetration sealant is deteriorated and in need of replacement.
- o Various stages of deterioration within the soffit indicating potential dry rotting and in need of repair and or replacement.
- o The isolated hole in the single-ply roofing membrane could allow for potential moisture intrusion into the system.

- o Routine maintenance should be performed to remove vegetative debris from the roofing membranes and the gutters and downspouts. Annual roofing inspections should be made by a qualified inspector to maintain manufacturer warranties. Sealant should be replaced at a minimum of every seven years to prevent drying and cracking. Ponding should be directed off the roof. Hole in the roofing membrane should be repaired with compatible material and the one pipe penetration should be properly flashing in accordance with manufacturer specifications.
- o Refurbish existing roof soffits.

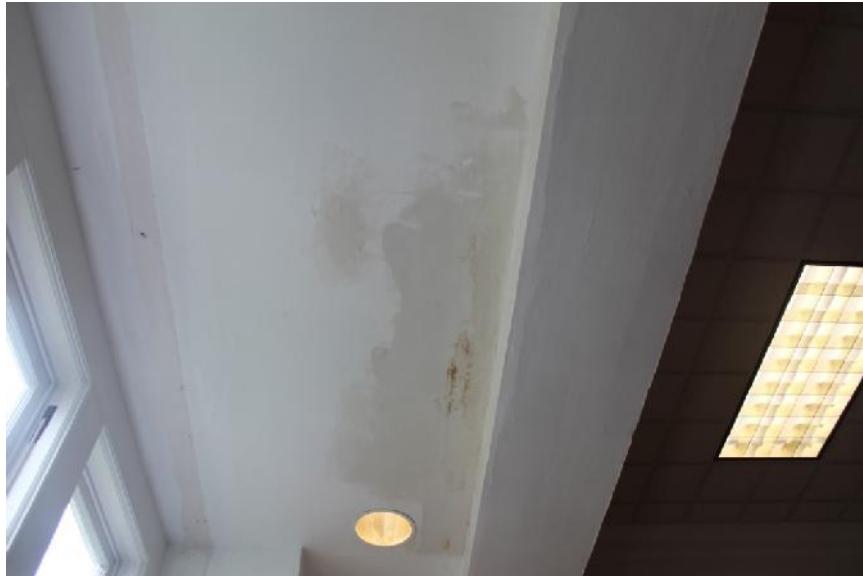
- o Interior water damage was observed in the original section of the library with various ceiling tiles exhibiting water stains. However, after performing an infrared scan of the areas no moisture was detected.

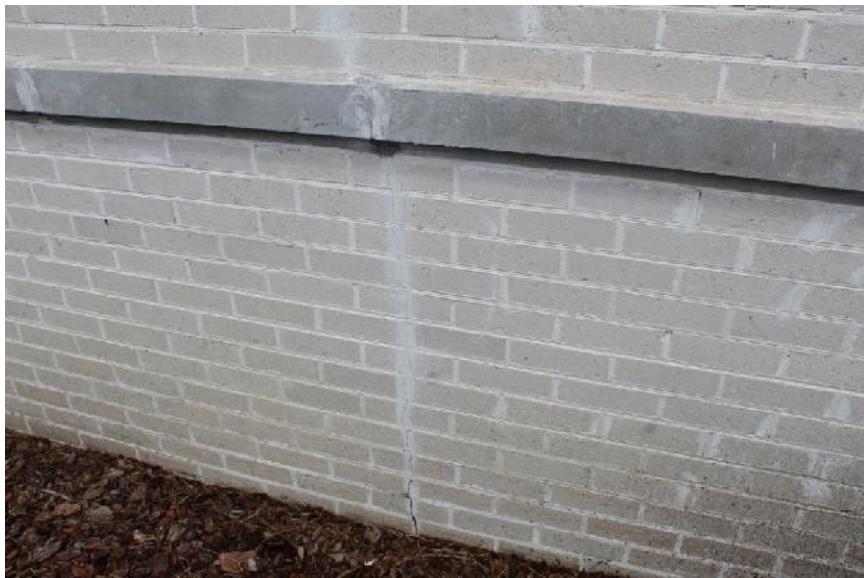
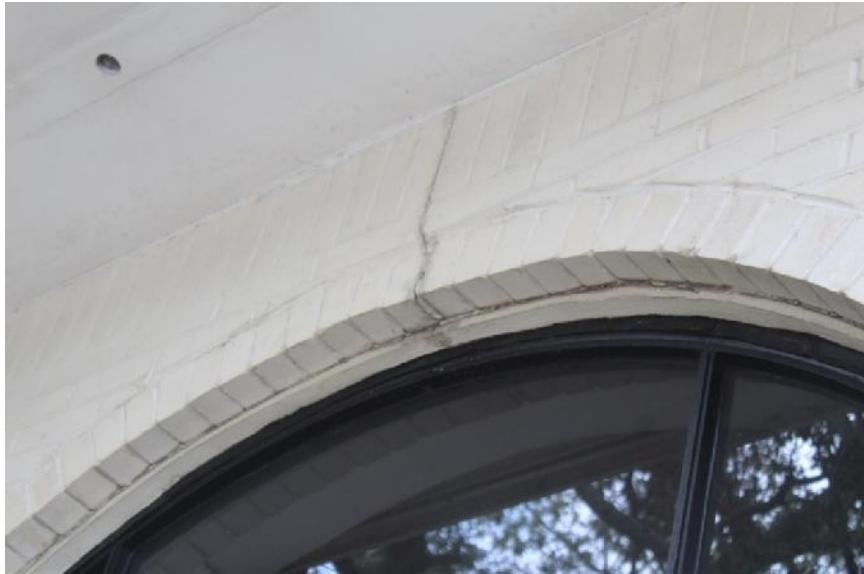
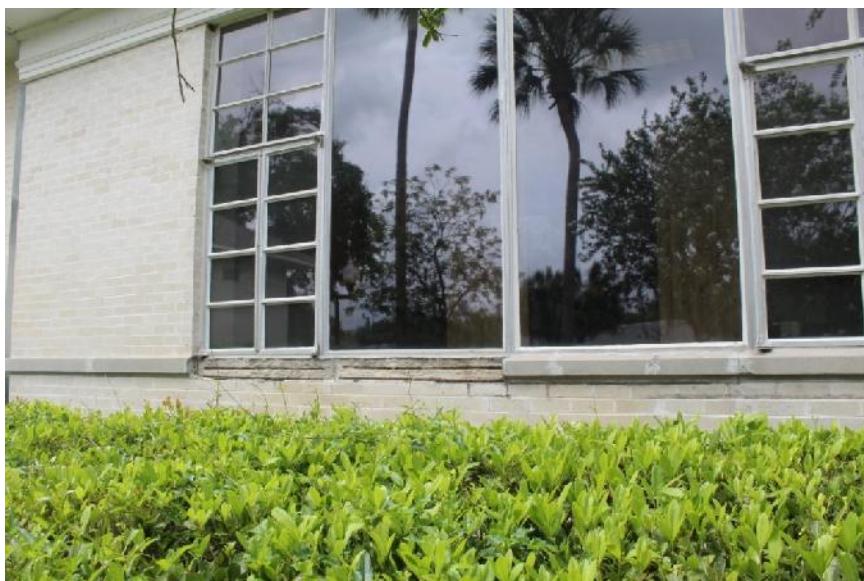
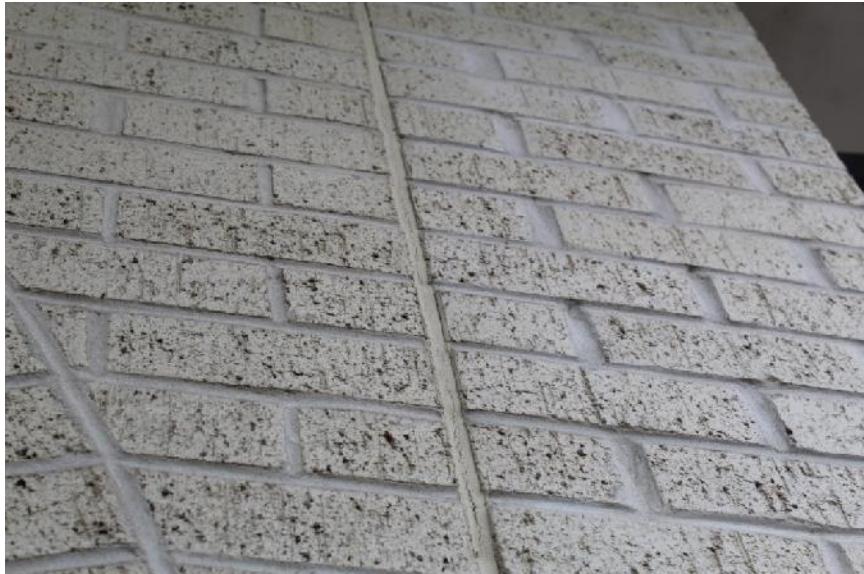
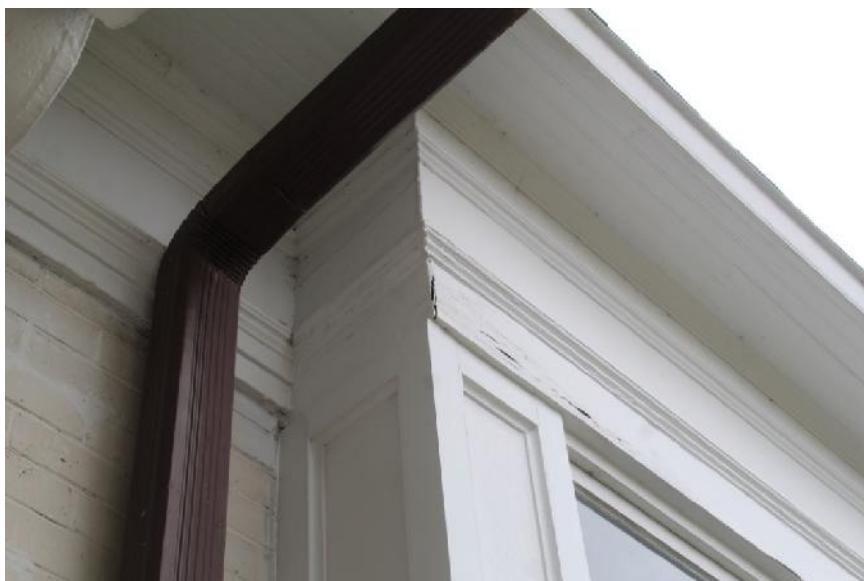
- The brick was observed to be in fair condition with mortar tuck points observed in the original section of the facility in need to be re-done. Areas of continuous fault crack lines were observed from the wall head to the wall sill. The south elevation was observed to have the concrete window sill missing and the re-bar displaced and corroded. Deterioration of the vertical control joint sealant. The decorative wood trim was observed to exhibit coating loss and isolated areas of dry rot.

- All areas show signs of brick wall cracking along fault lines (continuous fault crack from wall head to wall sill). The faults vary from through grout lines cracks to full brick splitting.
- Exposed rebar with missing concrete window sills and other sill exhibiting vertical and horizontal cracking.
- Deterioration of vertical control joints.
- Dry rotted wood trim around the original windows at the east elevation, north side.

- o Install brick control and expansion joints, re-tooling of faulty and failing grout lines and replacement of damaged brick.
- o Replace deteriorated sealant.
- o Repair and replace window sill concrete and rebar.

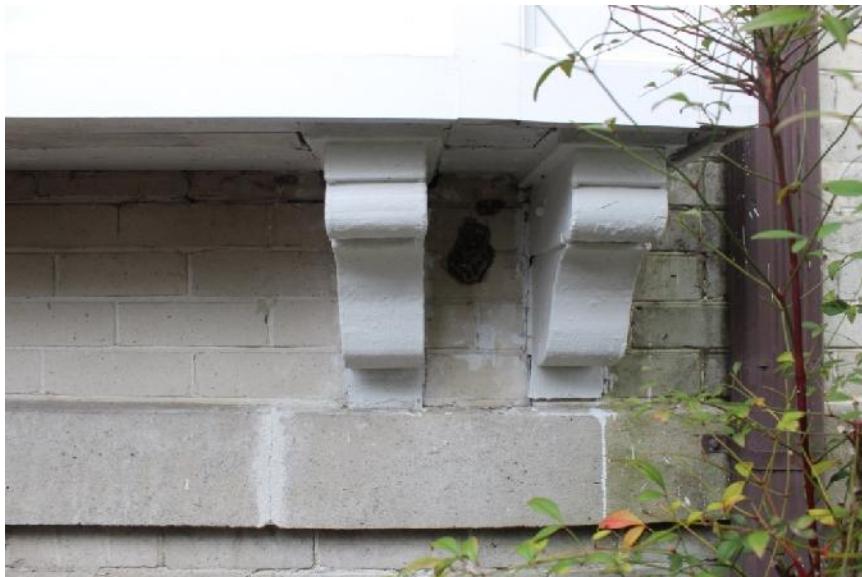
- o Inadequate brick control joints.
- o Deteriorated control joint sealant.
- o Missing window sill concrete with deteriorated re-bar.

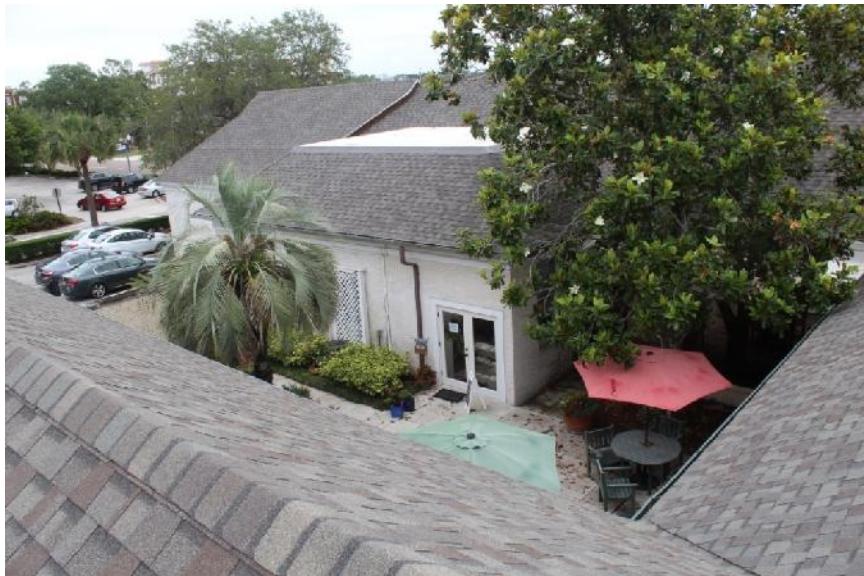
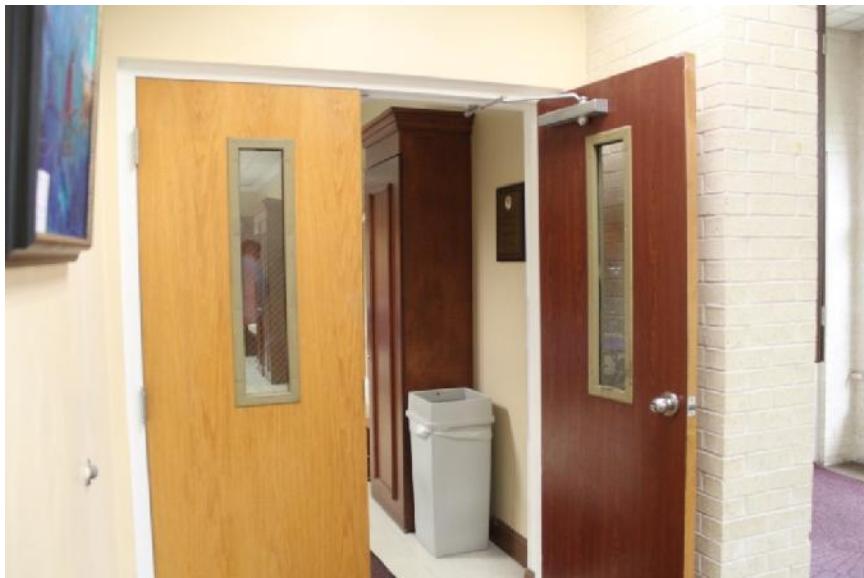
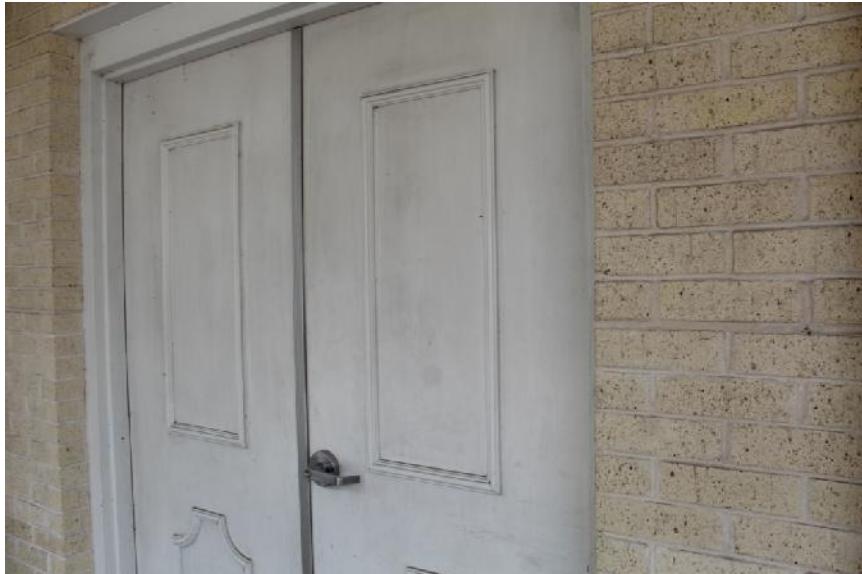
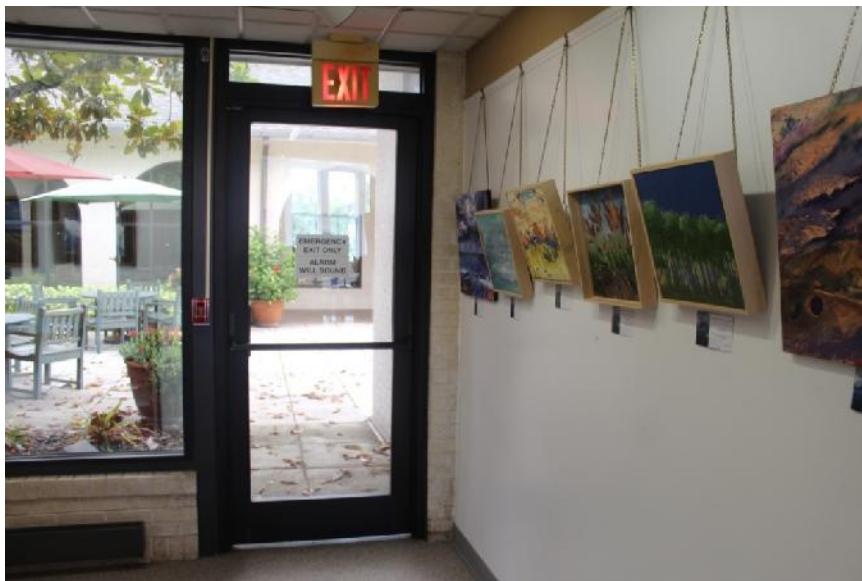
- o The wood doors are in Fair condition.
- o The metal hollow core doors are exhibiting signs of corrosions and are in poor condition.
- o The aluminum Adult Reading room door is in fair to good condition.
- o The original entry door was observed to be out of alignment and in need of maintenance but is in fair condition.

- The original front door needs re-alignment for proper closure.
- The corroded metal doors and framing at the west elevation need replacement for the mechanical and electrical rooms.

- Replace all hollow metal doors and provide additional weather stripping door hardware accessories.
- Conduct building wide door maintenance and refurbishment program to revitalize and maintain existing doors, to include door hardware upgrades such as kick plates, press pads etc., to reduce wear, tear and soiling on the doors.

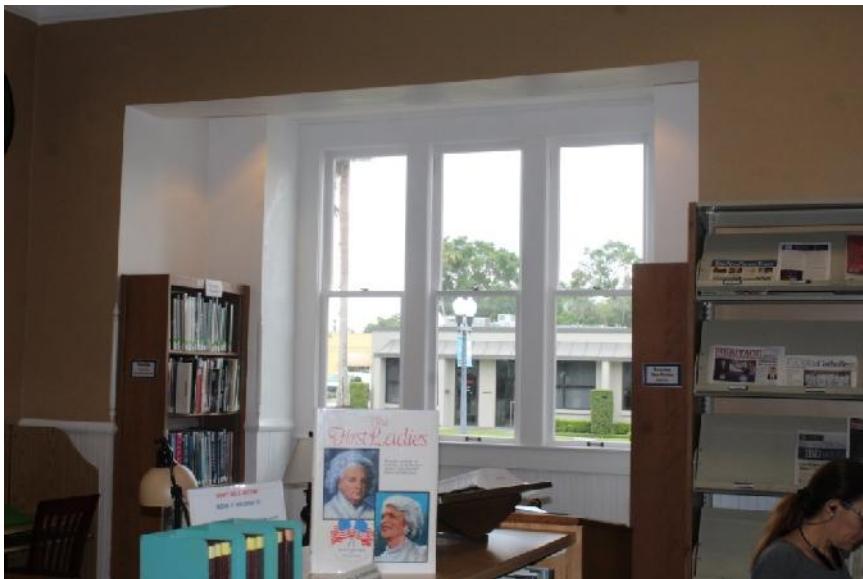
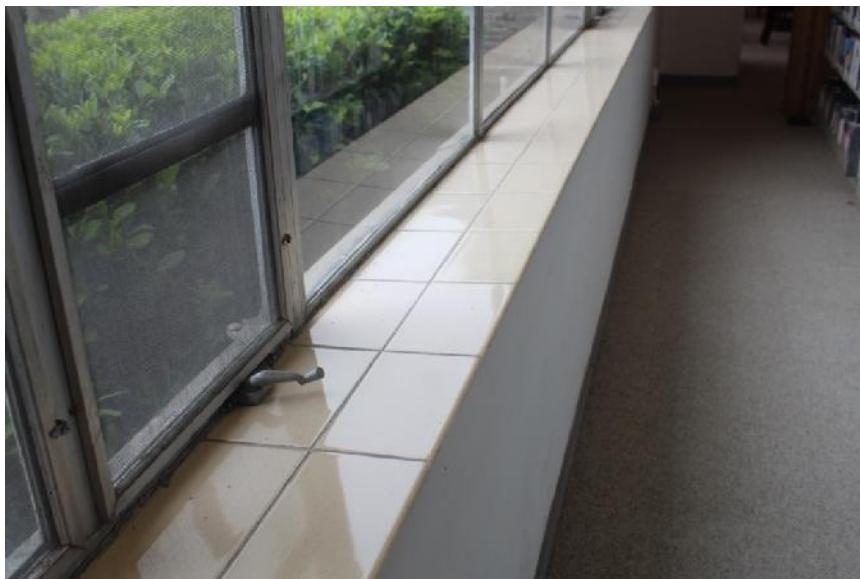
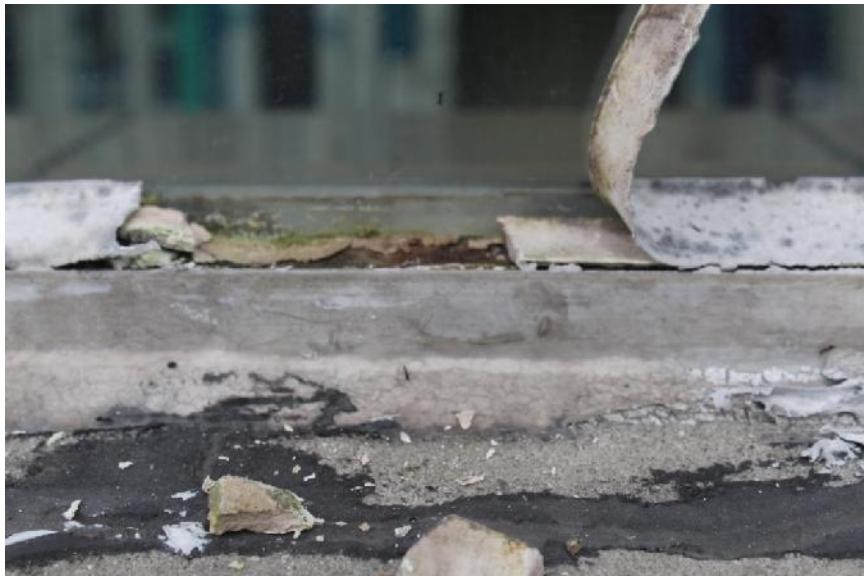
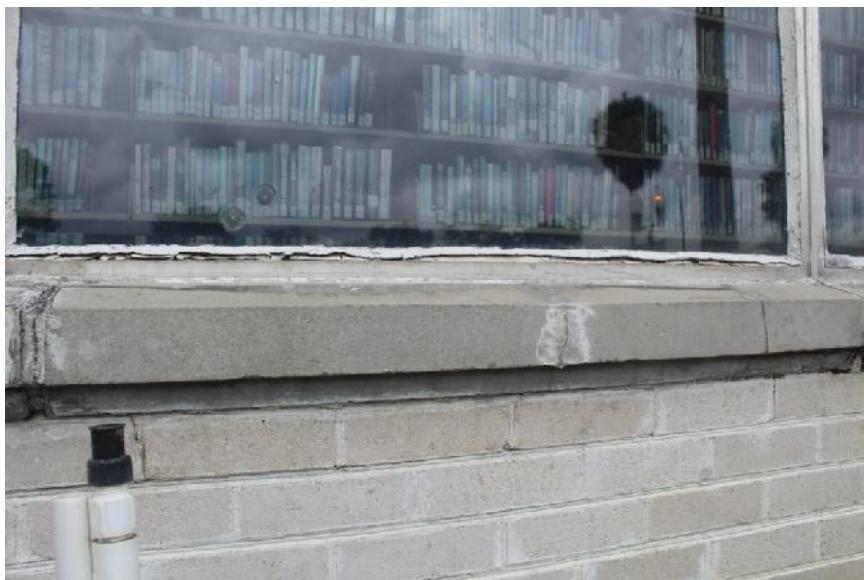
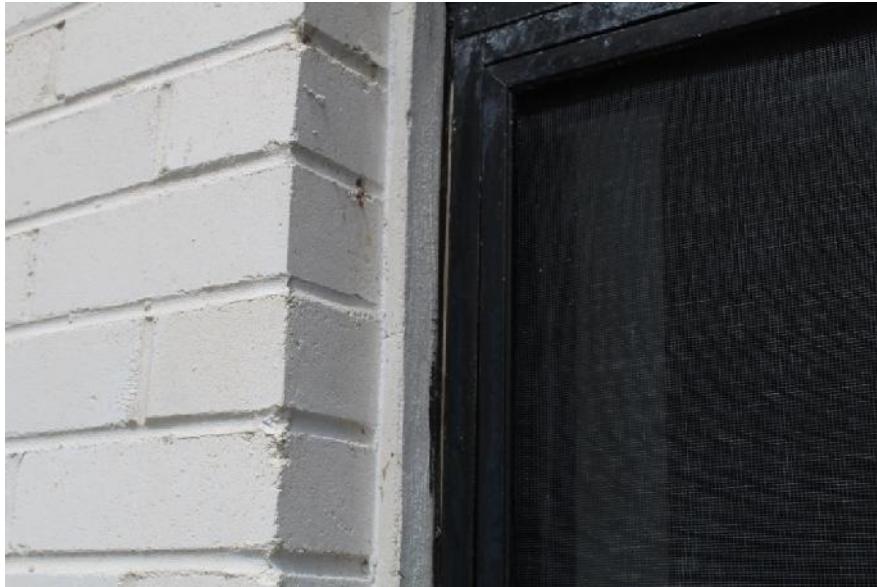
- The single pane aluminum windows along the 1959 wing addition show signs of deterioration of window sealant/caulking. The concrete window sills are also in a state of poor condition, due to several having signs of continued fault cracking and maintenance repair. The tile sill grout shows signs of deterioration along the window sill and needs repair. The deterioration of exterior sealant around the window frames needs removal and replacement.
- The cracking and breaking of the exterior window sills is potentially allowing moisture into the brick wall cavity.
- The landscaping sprinkler heads spray upwards toward the underside of the window sill and into the cracks.

- Replace the casement windows with new energy efficient storefront aluminum framed windows.
- Refurbish the exterior concrete window sills.
- Remove and replace exterior window sealant at the west elevation aluminum, framed windows.

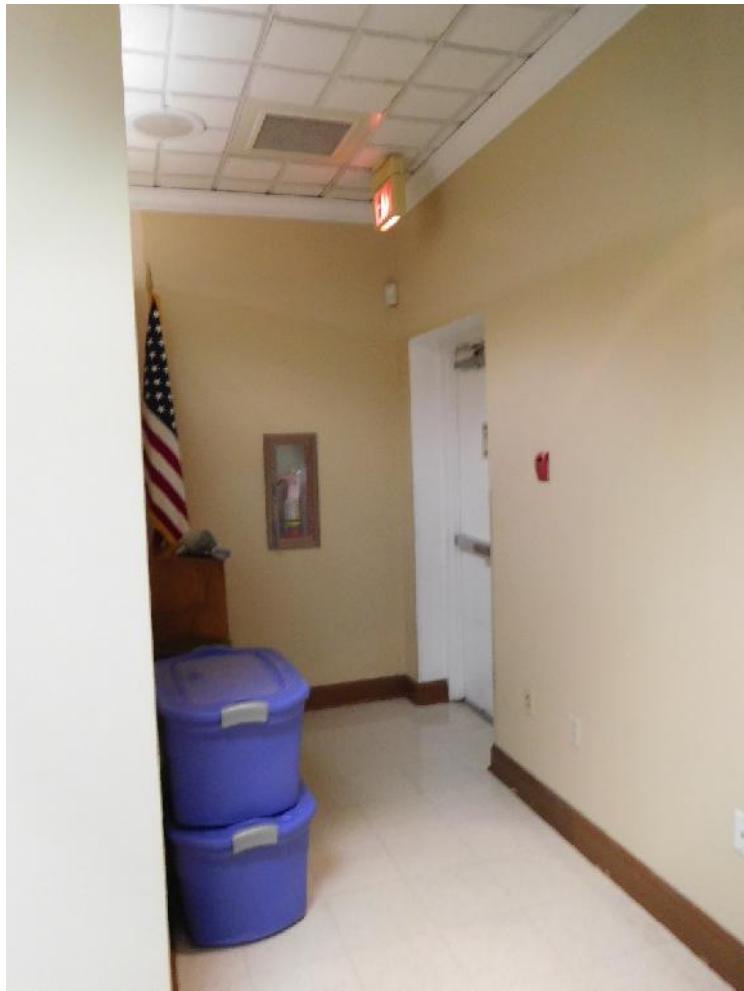
Community Room Egress Exit

-]/ Emergency Lighting and Exit Signs- are comprised of a variety of illuminated directional sign and combination directional sign and lighting packs along all exit routes, signage is generally unobstructed, except for the exit sign behind the Teaching Kitchen. At the time of a prior remodeling of the Teaching Kitchen, a visible directional sign was not included to indicate the emergency exit when the addition blocked visibility of the existing emergency egress. Additionally, it does not appear that exterior lighting was provided to at all exit locations leading to a public way. Without a photometric study this cannot be confirmed.

- o Provide additional directional signage for emergency exit in the community room and conduct an exterior photometric study to confirm if lighting that levels meet FBC requirements for illuminated means of egress to a public way.
- o Test all fire alarm systems to ensure a proper working order.
- o Sort and organize the concentration of combustibles in the storage area of the mezzanine level to minimize fire hazard potential.
- o Relocate fire extinguishers in the Adult Reading Room or replace them within semi-recessed cabinetry.

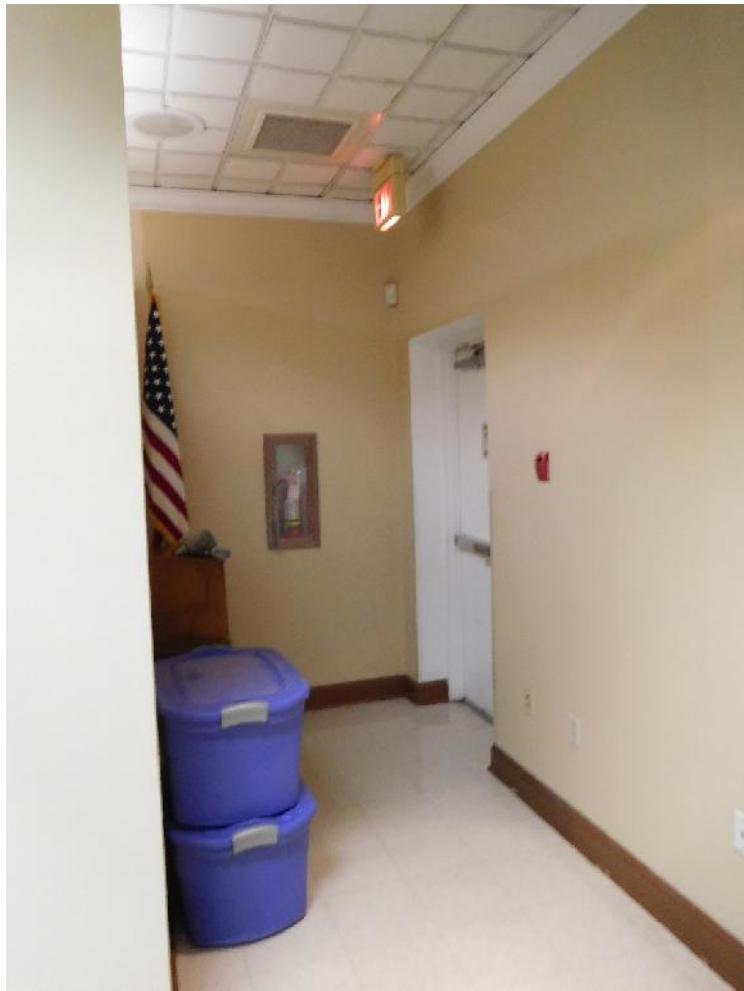
Community Room Egress Door

- At the time of previous remodel to add Teaching Kitchen, visual connection to emergency exit sign was compromised. It does not appear that relocation of existing or adding replacement emergency exit signage was provided to address this visual break. Additionally, it does not appear that specific exterior lighting was provided to all exit locations leading to a public way. Without a photometric study this cannot be confirmed.

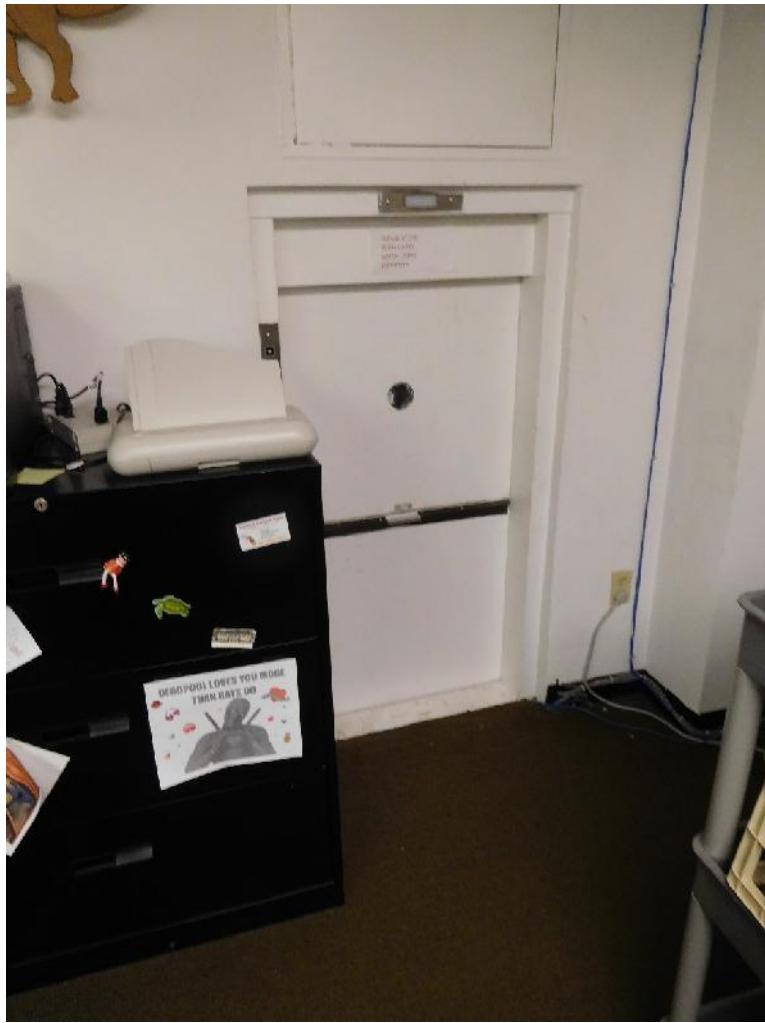
Book Lift

- The condition of the book lift is Fair. It is a dated system that does not show signs or observations of routine maintenance and servicing.

- o Have a lift-manufacturer or lift-servicing technician inspect conditions of lift, gears, motor and doors; then service accordingly.

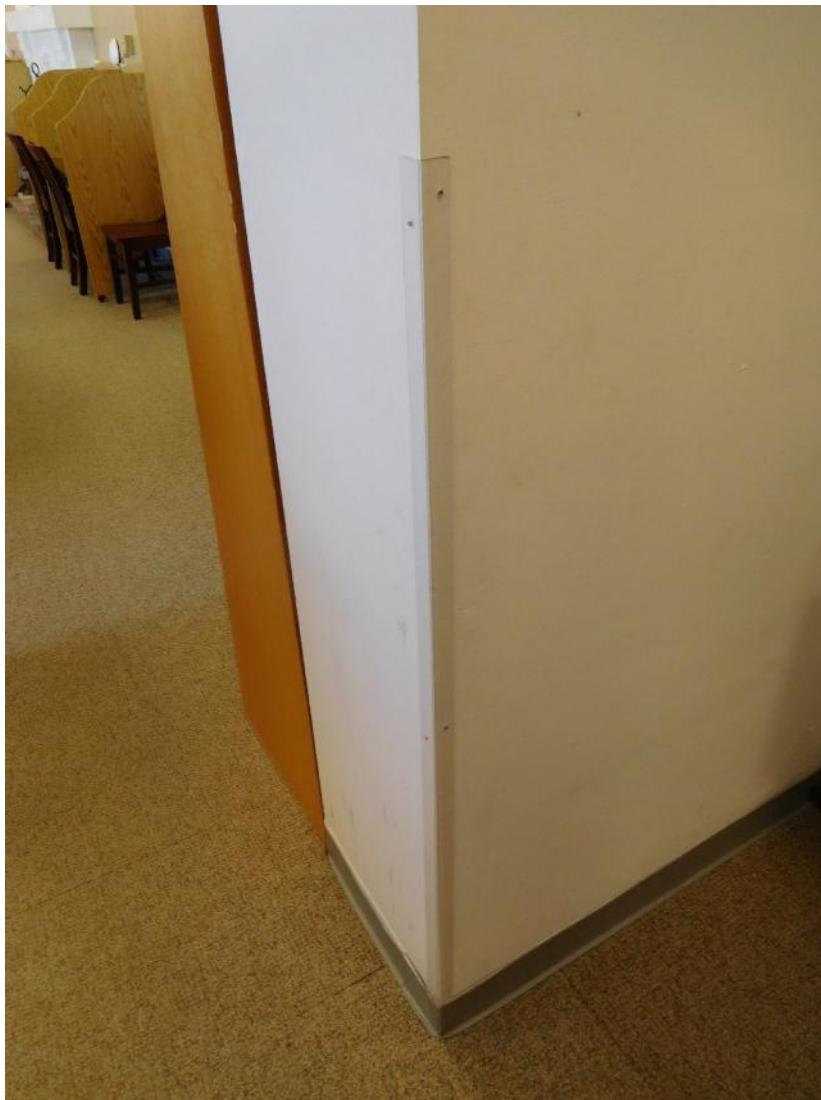
- Several areas have light duty corner guards in place. Regarding an overall facility coverage, they are inconsistently placed and relegated to general zones, rather than a comprehensive protection to entire facility. In several areas these light duty corner guards are failing due to active environmental conditions that limit their intended effective use.

Example of light duty corner guard

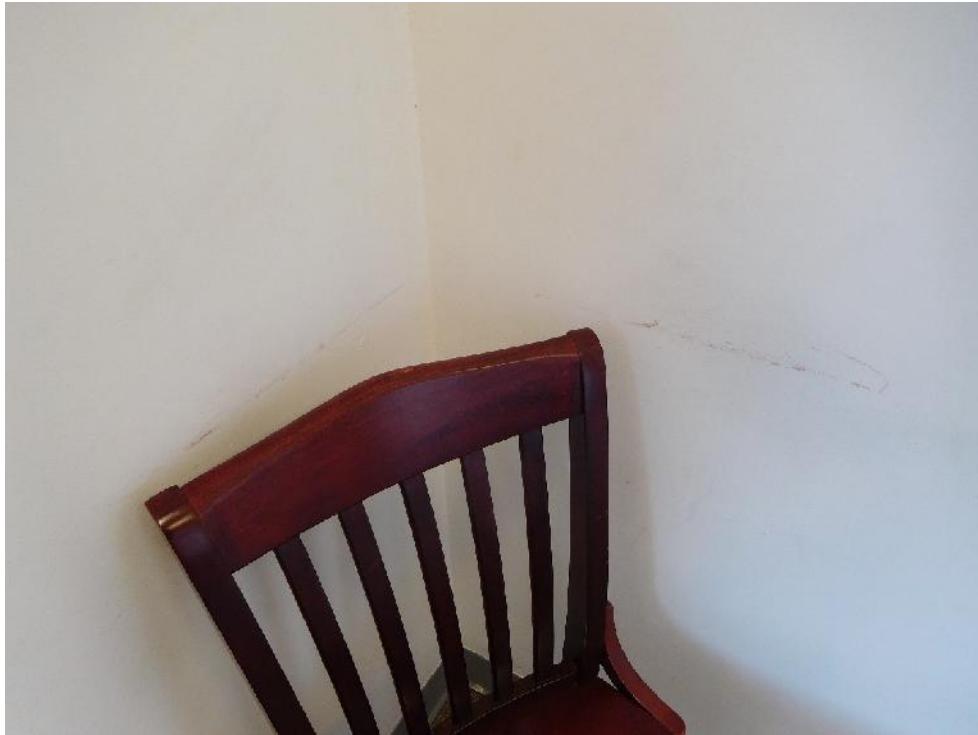
- Where public seating is presented with loose furnishing chairs, associated adjacent walls show signs of abrasive wear from regular contact with chair backs.

Chair scuffing of wall surface

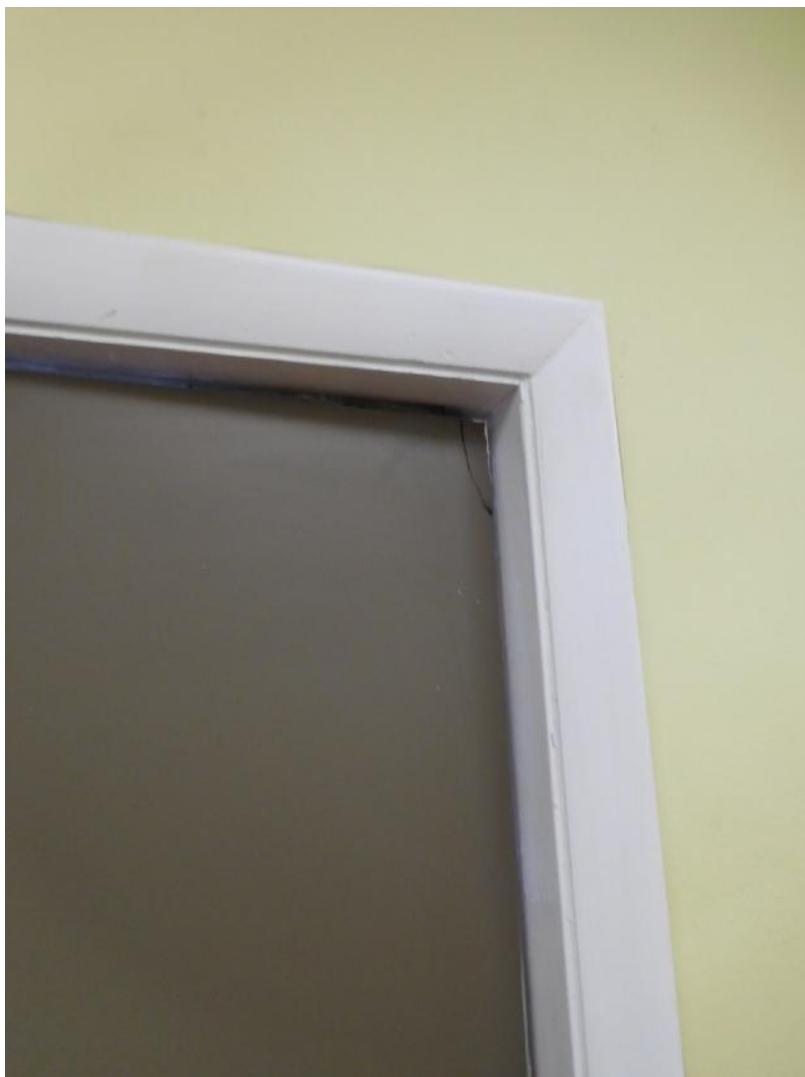
- The most heavily utilized doors are showing signs of excessive wear. Deferring maintenance repair or refurbishment will lead more quickly toward door failure, often ○ these doors and their state of deterioration are publicly visible.

Damaged Staff Room Door

- Conduct building wide door maintenance and refurbishment program to maintain or revitalize existing door assemblies. Include door hardware upgrades such as kick plates, press pads etc., to reduce wear, tear and soiling on doors.
- Remove doors and frames to staff offices and replace with commercial grade wood door and frame assemblies to match existing office.

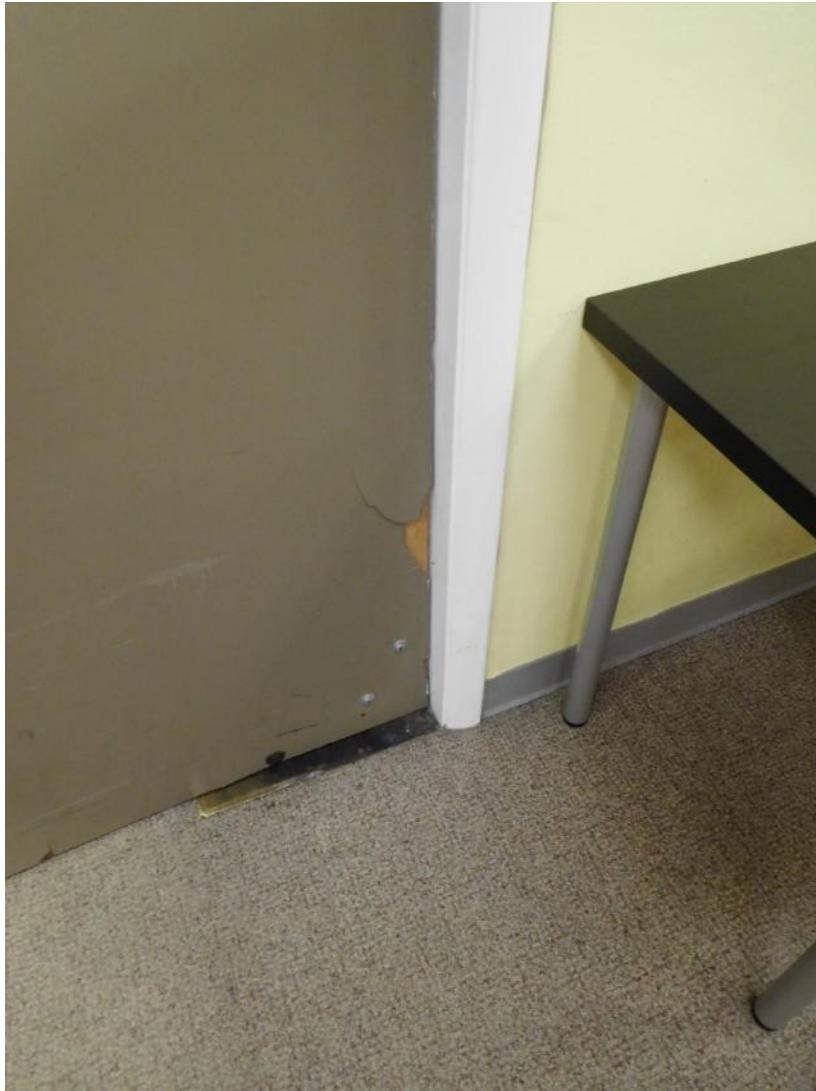
Damaged Staff Room Door

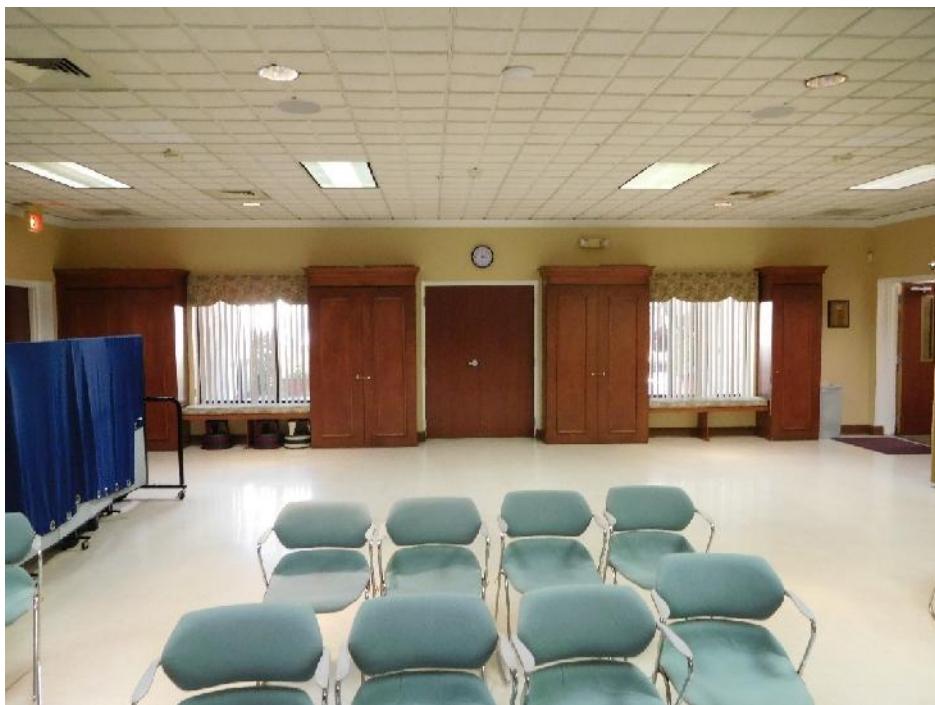
Community Room Ceiling Tiles

- Acoustical ceiling tile is in Poor condition most notably due to its service life. There is discoloration, warping, sagging, edge condition deterioration and damaged tiles that have not been replaced. In some areas, missing tiles have either been replaced with dissimilar type and finish, or not been replaced altogether.
- Gypsum board hard ceilings are generally in Good to Fair condition.

- o Comprehensive removal and replacement all Acoustical Ceiling Tiles (ACT). At that time replace the surface mounted electrical conduit inside of the ACT system. (It was noted due to the age and obsolescence of the existing square ceiling tiles, upgraded lighting, data and electrical lines were surface mounted to the ceiling system).
- o Consider servicing and updating light fixtures.

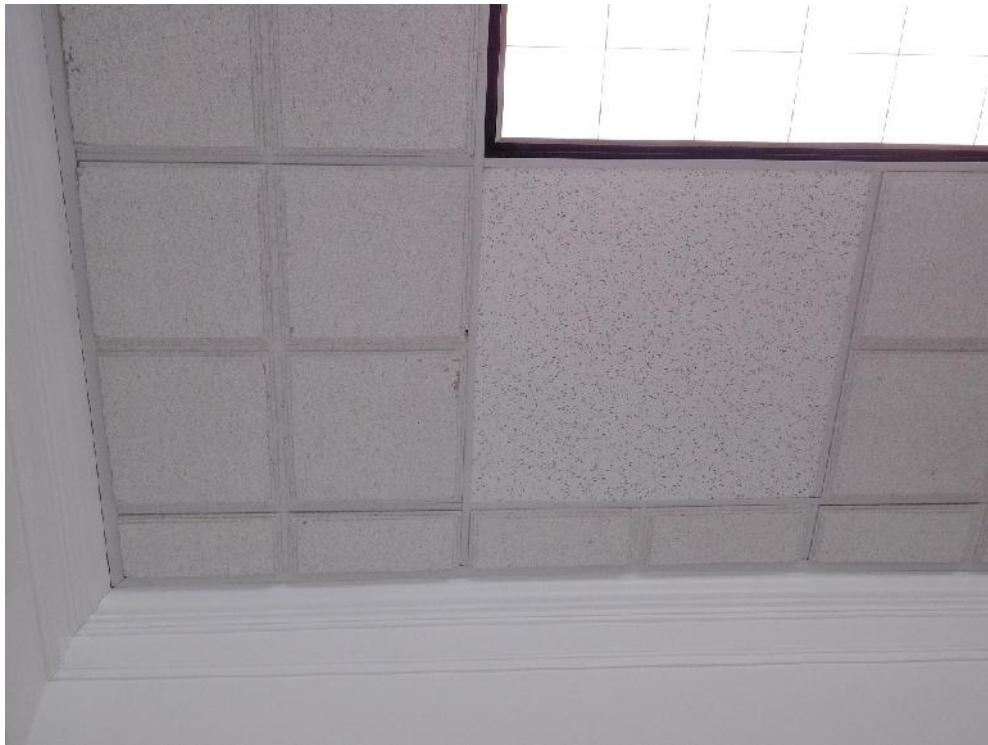
- In some areas where damaged tiles have been removed, they have either been replaced with dissimilar type and finish, or not been replaced altogether. Both these conditions occur within public observation areas.

Mis-matched ceiling tiles

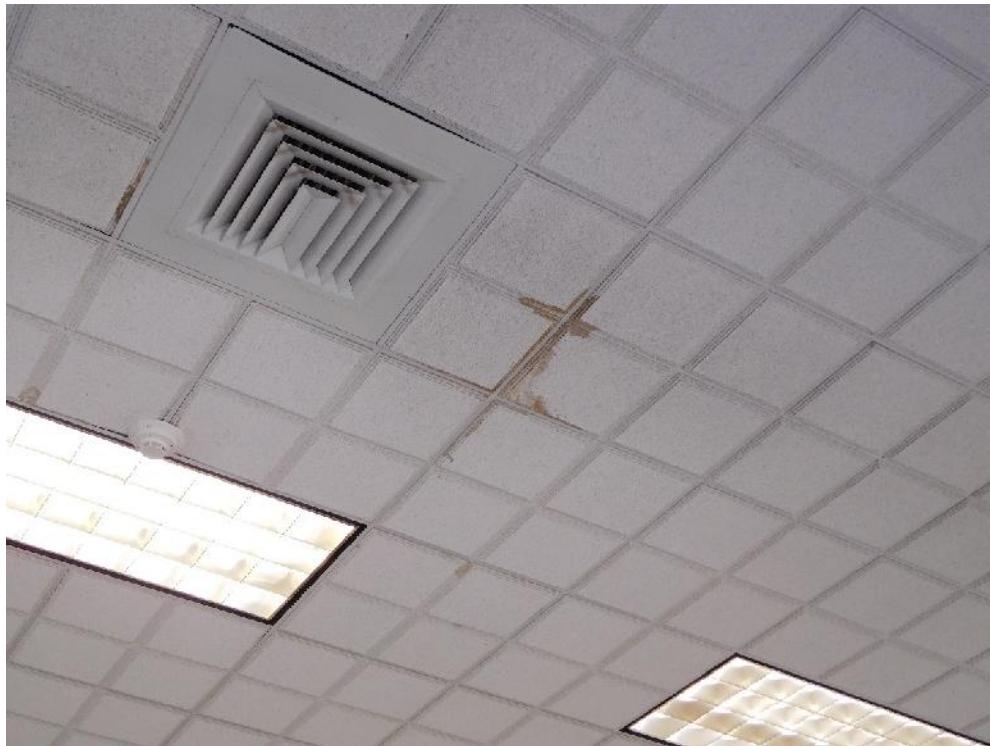
- In areas where the gypsum board hard ceilings have received damage from water intrusion they have either not been fully remediated (Adult Reading Room) or have been spot fixed and painted over. In the case of the later, which accentuates a noticeable visual variation between what has been spot-fixed and what has survived. Refurbishment is limited to the affected area, effectively still highlighting the treated area by the variation between the refurbishment and unaffected area.

Water stain of ceiling tiles

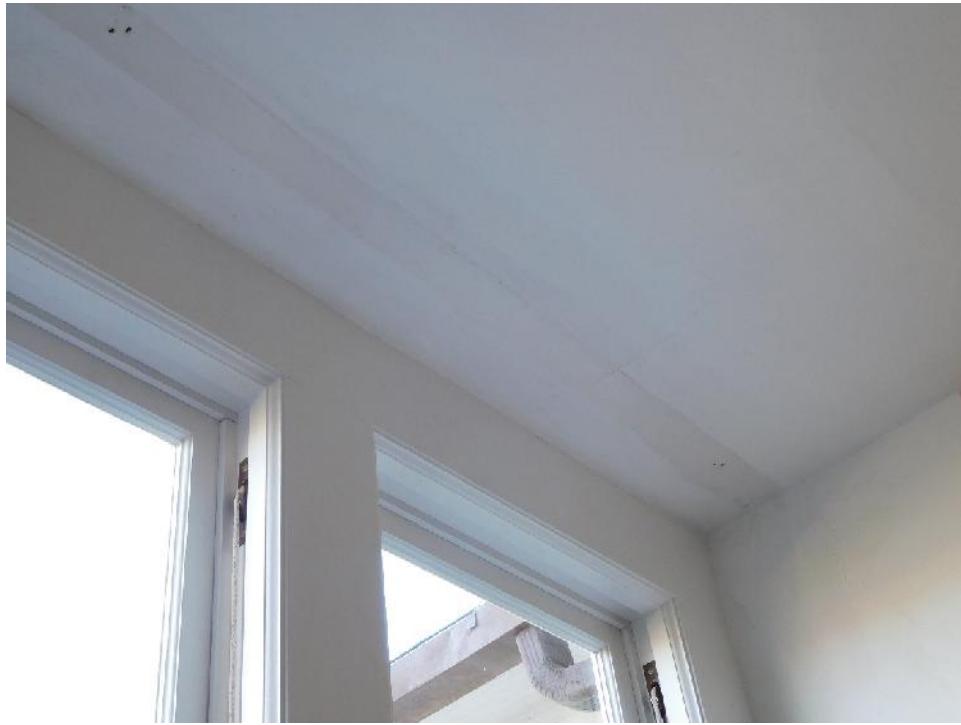
- o Original building wood frame windows in the Adult Reading Room have signs of water intrusion above the interior window head, jamb wall return and sill.
- o The single pane aluminum windows along the 1959 wing addition show signs of water damage and intrusion along the window jamb.

Adult Reading Room wood window system; note water damage

- o Remediate and repair water damage to interior finishes.
