The City of Maitland Library: Facilities Assessment Report

BORRELLI + PARTNERS

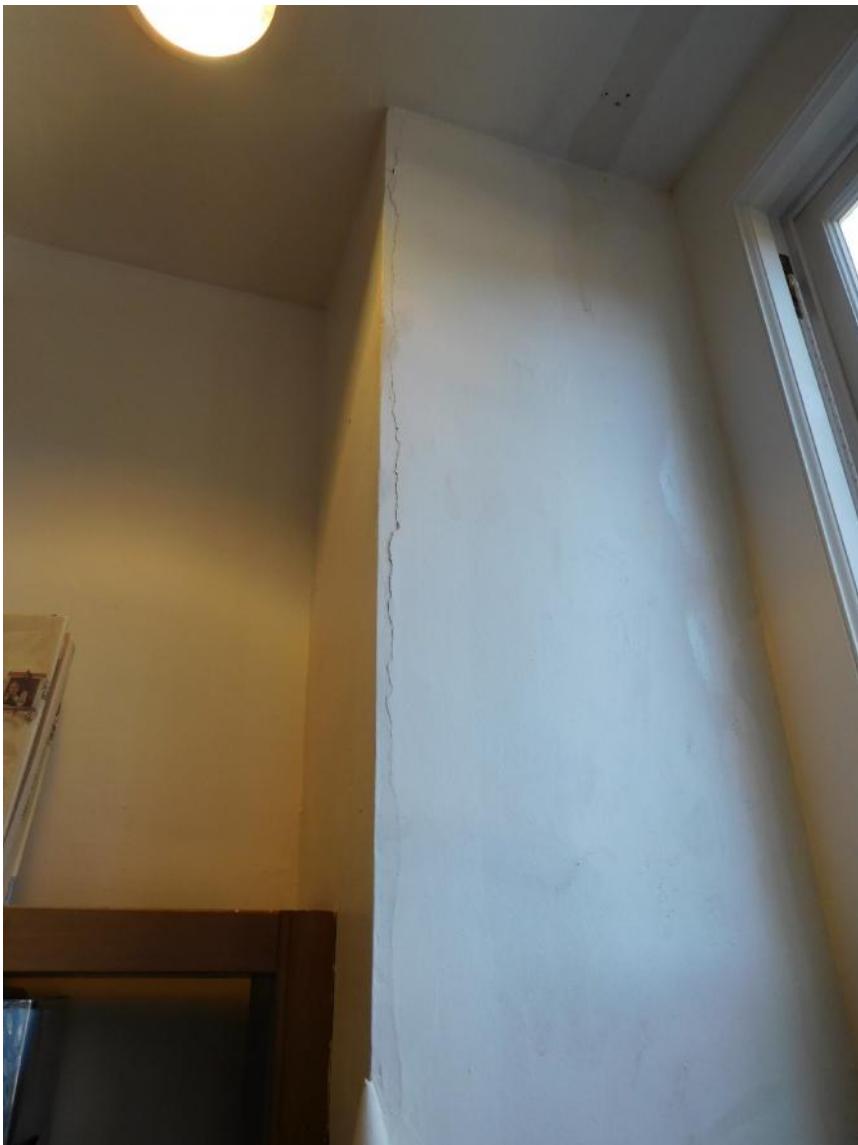
Adult Reading Room wood window system; note water damage

- o Remediate and repair water damage to interior finishes.

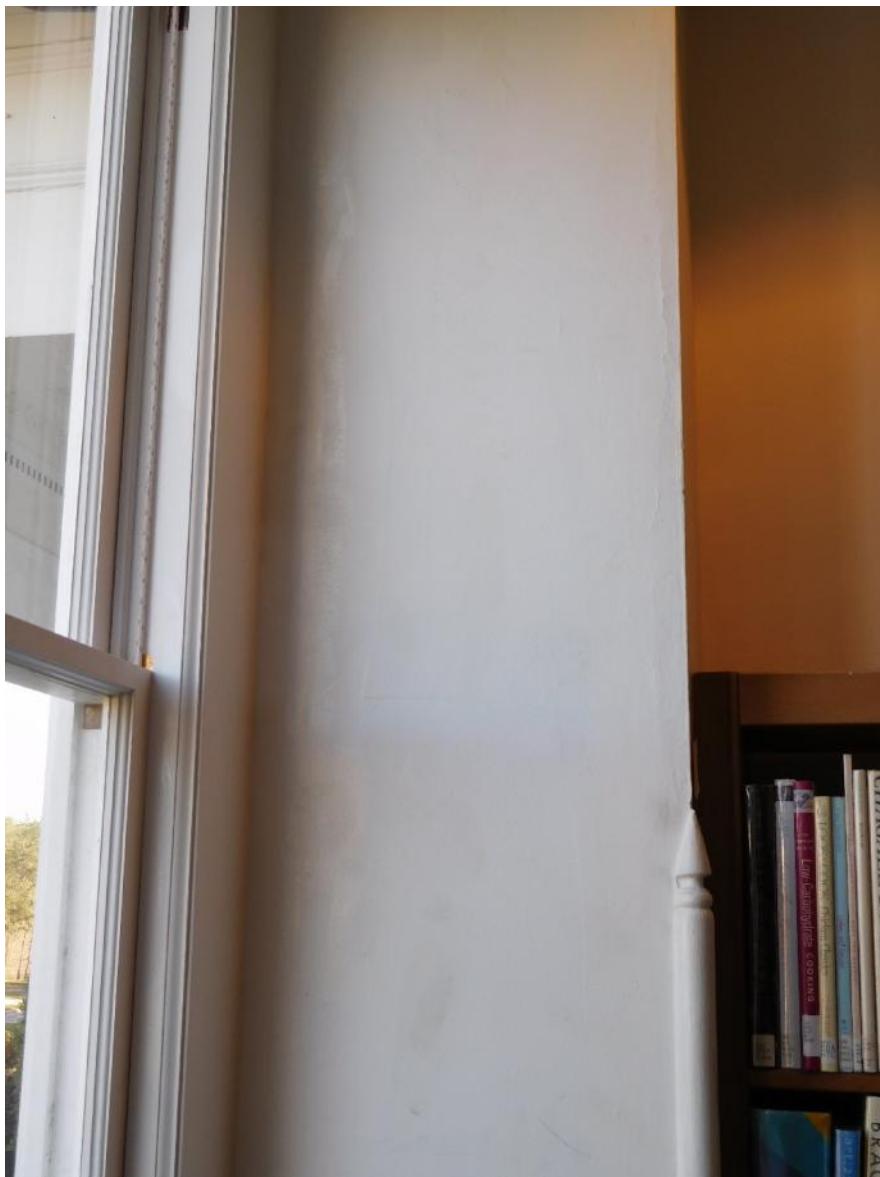
Adult Reading Room wood window system; note water damage

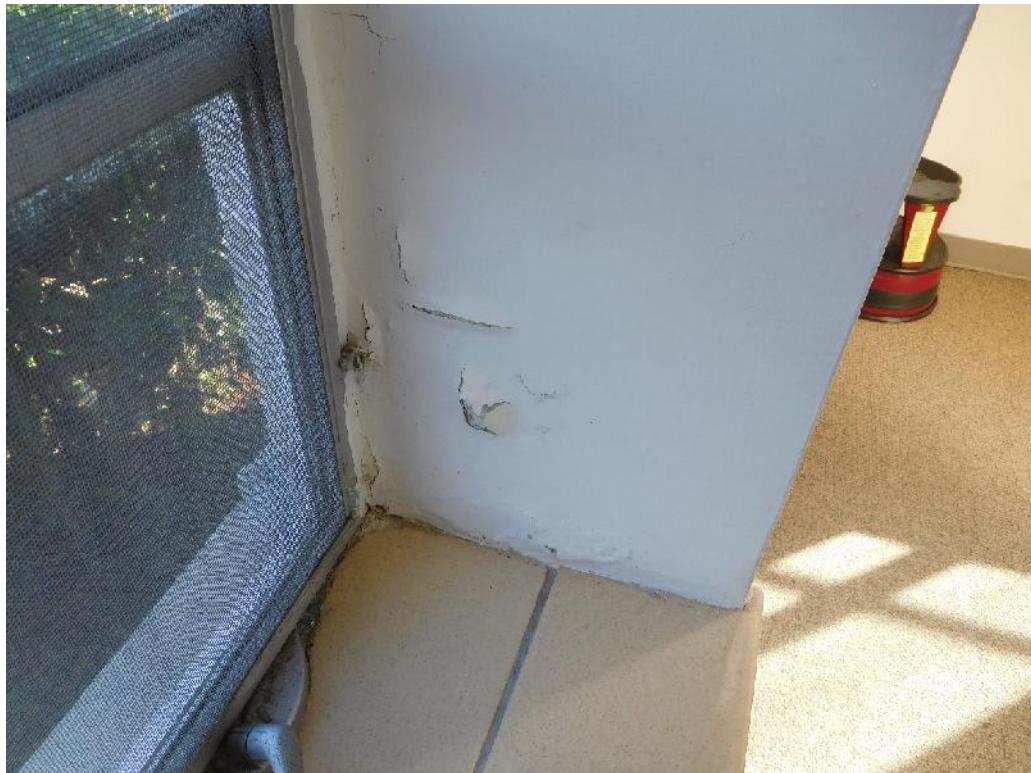
Adult Reading Room; note water damage

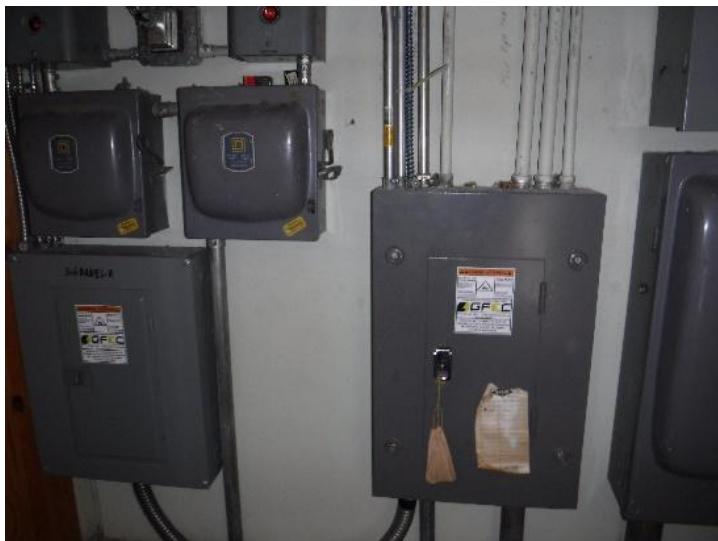
Electrical Closet Sub-Panels

There is an Electrical Closet in the older part of the building in the Book Sales Room that contains disconnect switches and (2) sub-panels. All of this equipment is old but appears to be in good condition. Sub-Panel "A" on the left is a Square D QO Series panel, 125 amp, 208Y/120V, 3 phase, 16 circuit, main lug only with 7 spaces.

Sub-Panel "B" on the right is a Square D QO Series panel, 125amp, 208Y/120V, 3 phase, 20 circuit, main lug only with no spaces or spares.
