The City of Maitland Library: Facilities Assessment Report

BORRELLI + PARTNERS

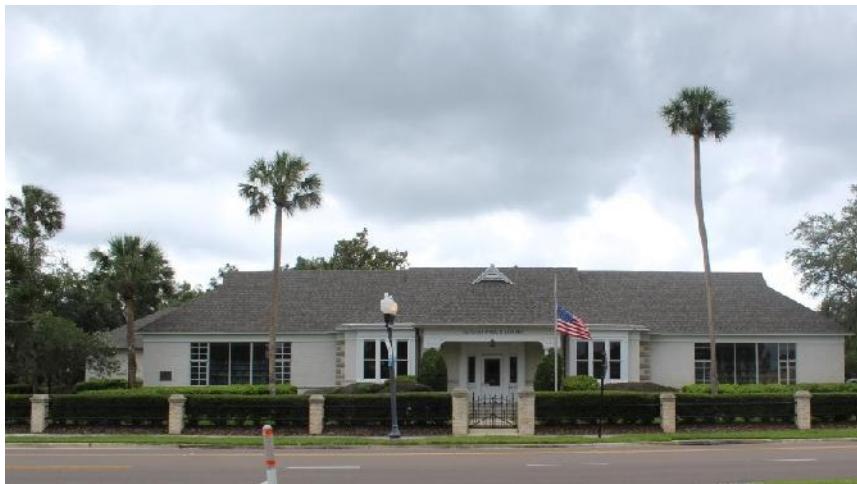
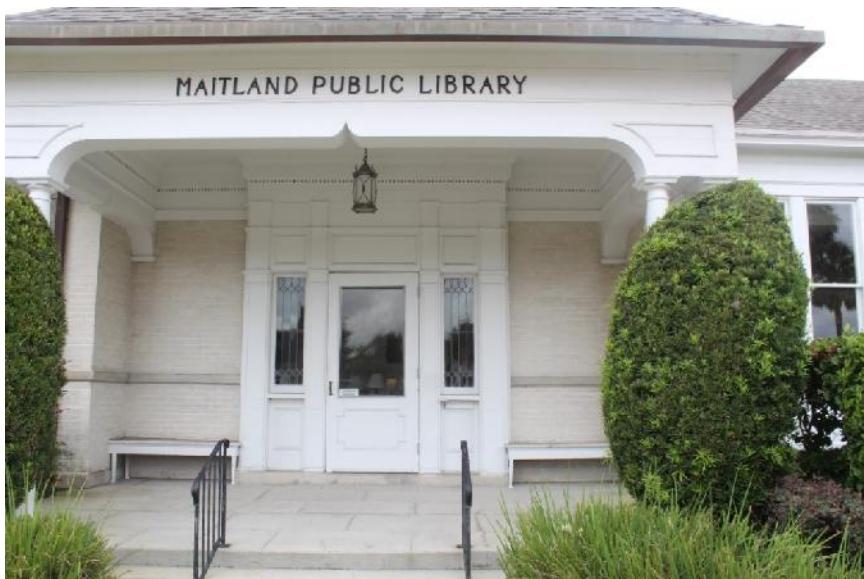
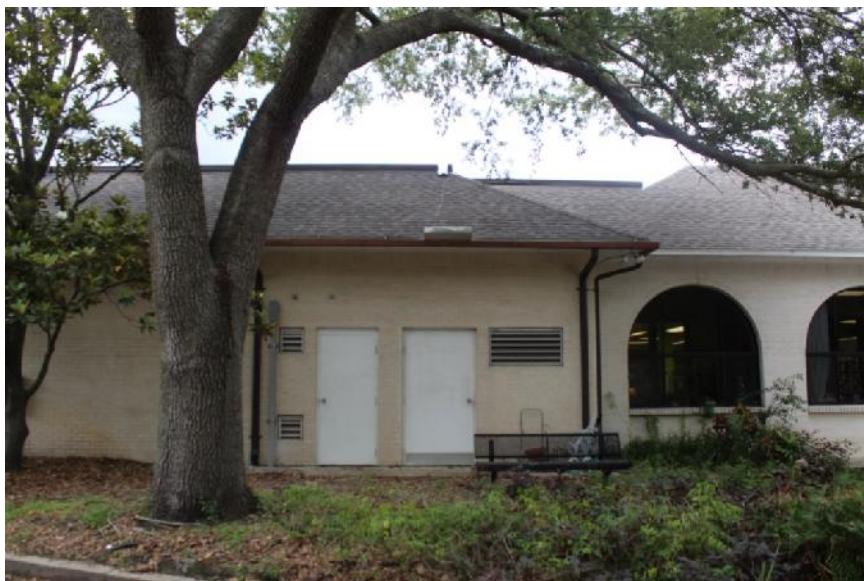
Entrances & Doors

The building has a mixture of wood frame and entry doors. The east entrance is the original building façade with wood framing and single glass panes and a double hollow core wood door at the meeting room located at the inner courtyard's east elevation. The inner court yard houses the bookstore's double wood framed full lite doors and the coated aluminum framed single door with a full lite pane for Adult Reading area. The west elevation has hollow core metal doors with metal framing servicing the mechanical and electrical rooms in addition to the staff entrance

- o The wood doors are in Fair condition.
- o The metal hollow core doors are exhibiting signs of corrosions and are in poor condition.
- o The aluminum Adult Reading room door is in fair to good condition.
- o The original entry door was observed to be out of alignment and in need of maintenance but is in fair condition.

- o The weather stripping needs replacement on the doors.

- The original front door needs re-alignment for proper closure.
- The corroded metal doors and framing at the west elevation need replacement for the mechanical and electrical rooms.

- Replace all hollow metal doors and provide additional weather stripping door hardware accessories.
- Conduct building wide door maintenance and refurbishment program to revitalize and maintain existing doors, to include door hardware upgrades such as kick plates, press pads etc., to reduce wear, tear and soiling on the doors.

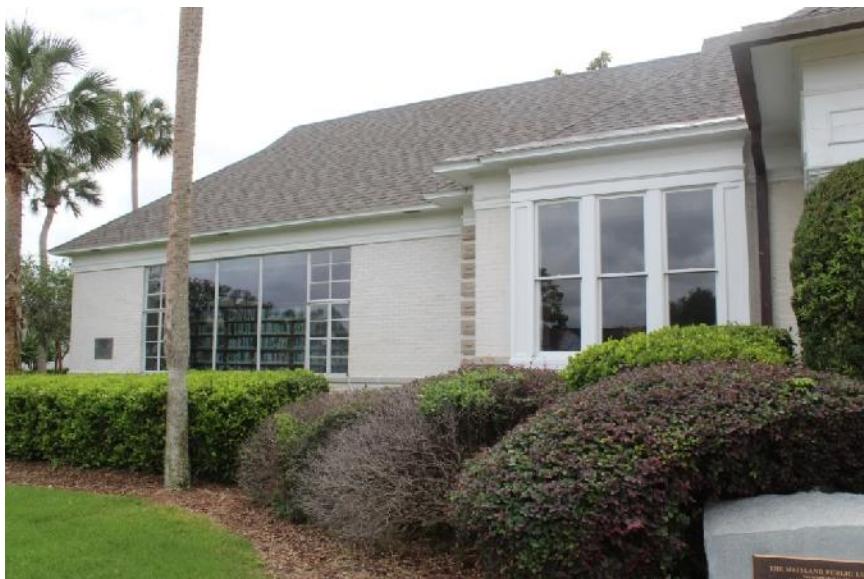
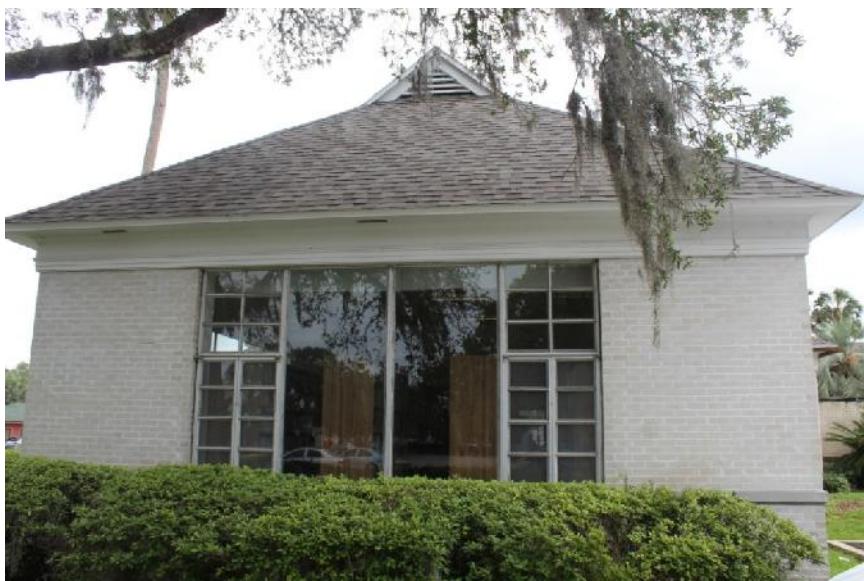
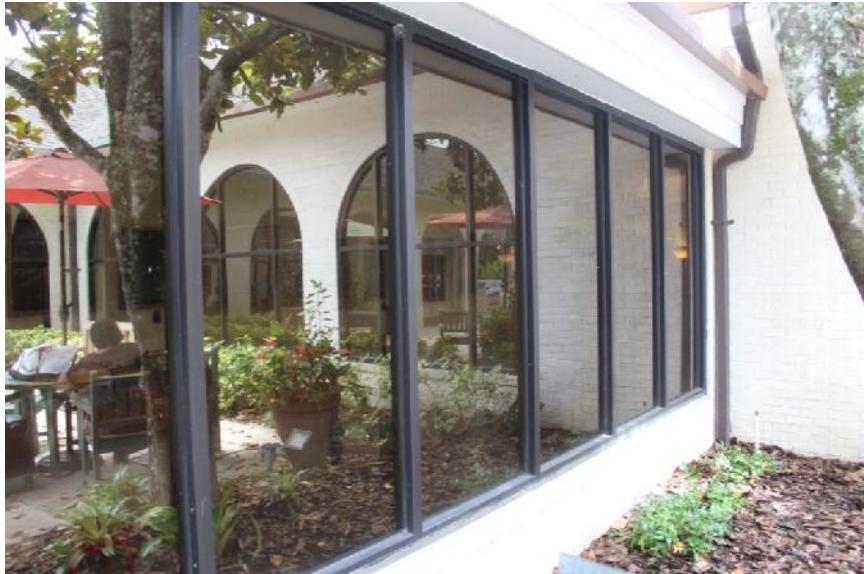
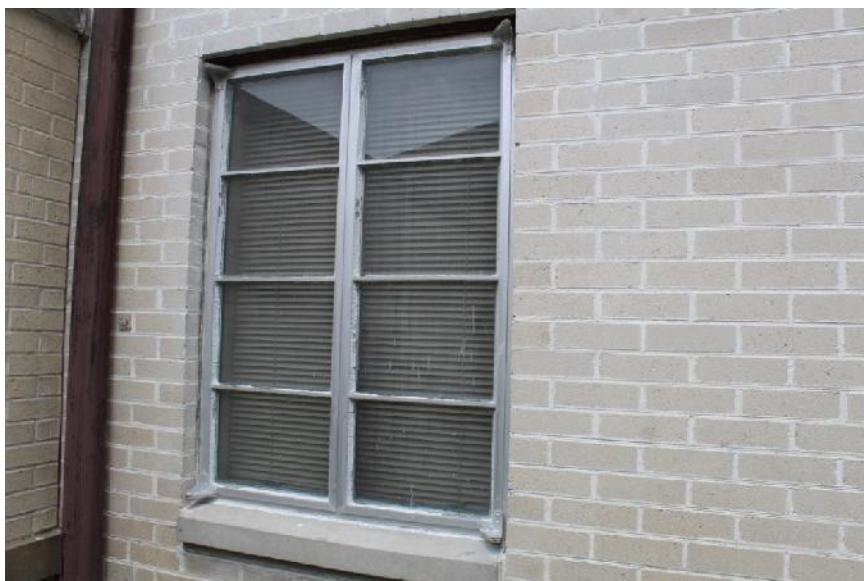
- The original building windows appeared to be in generally good condition overall and appear to have been recently repaired/ replaced.
- The original buildings' door sidelight windows were observed to be in fair condition except for two panes that were observed to be cracked.
- The casement windows located at the north and south wings were observed to be in poor condition with the sealant observed to be hardened and breaking loose from the windows.
- The exterior window sills were observed to be cracked and displaced from their original conditions.
- The exterior sealant around the window frames was observed to be in a state of deterioration.
- The anodized aluminum storefronts appear to be in good service repair.

- o The single pane windows with the sealant deterioration is allowing for insect penetration, heat and cooling loss, and moisture intrusion into the system.

- The single pane aluminum windows along the 1959 wing addition show signs of deterioration of window sealant/caulking. The concrete window sills are also in a state of poor condition, due to several having signs of continued fault cracking and maintenance repair. The tile sill grout shows signs of deterioration along the window sill and needs repair. The deterioration of exterior sealant around the window frames needs removal and replacement.
- The cracking and breaking of the exterior window sills is potentially allowing moisture into the brick wall cavity.
- The landscaping sprinkler heads spray upwards toward the underside of the window sill and into the cracks.

- Replace the casement windows with new energy efficient storefront aluminum framed windows.
- Refurbish the exterior concrete window sills.
- Remove and replace exterior window sealant at the west elevation aluminum, framed windows.

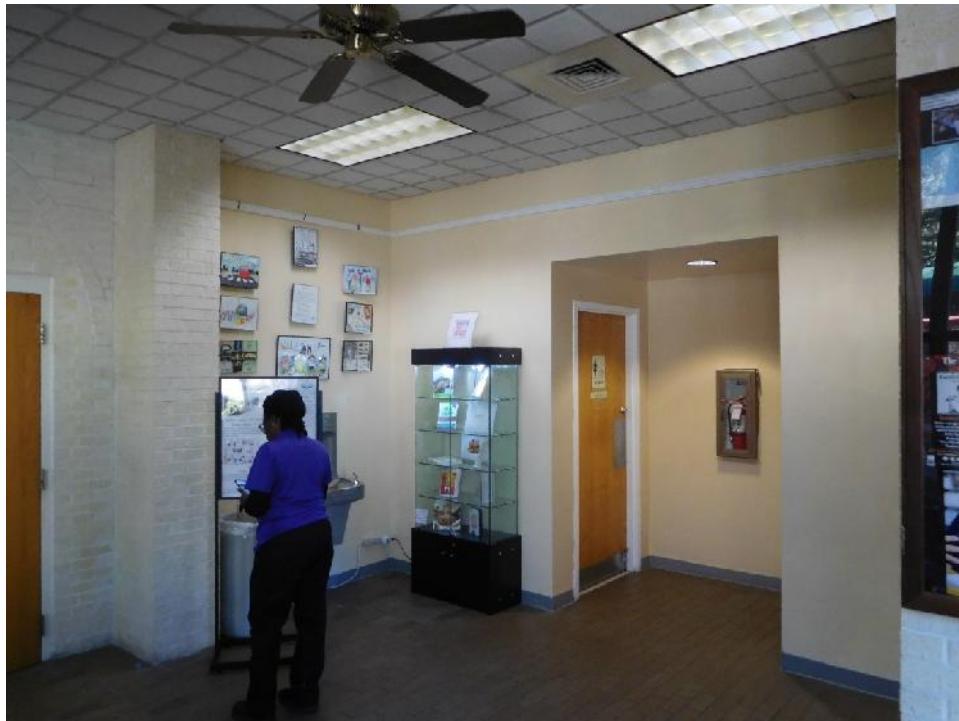
- Lobby Restroom does not have library staff observability unless the lobby doors are open. rooms are accessible to the public prior to them passing a staff observation check point. This arrangement could pose a security concern.
- Mezzanine Staff Restroom fixture and millwork were residential in nature and may not survive the same life cycle and durability expectations of commercial grade fixtures and finishes used elsewhere in facility.

Lobby Restroom not observable by Library Entry Desk

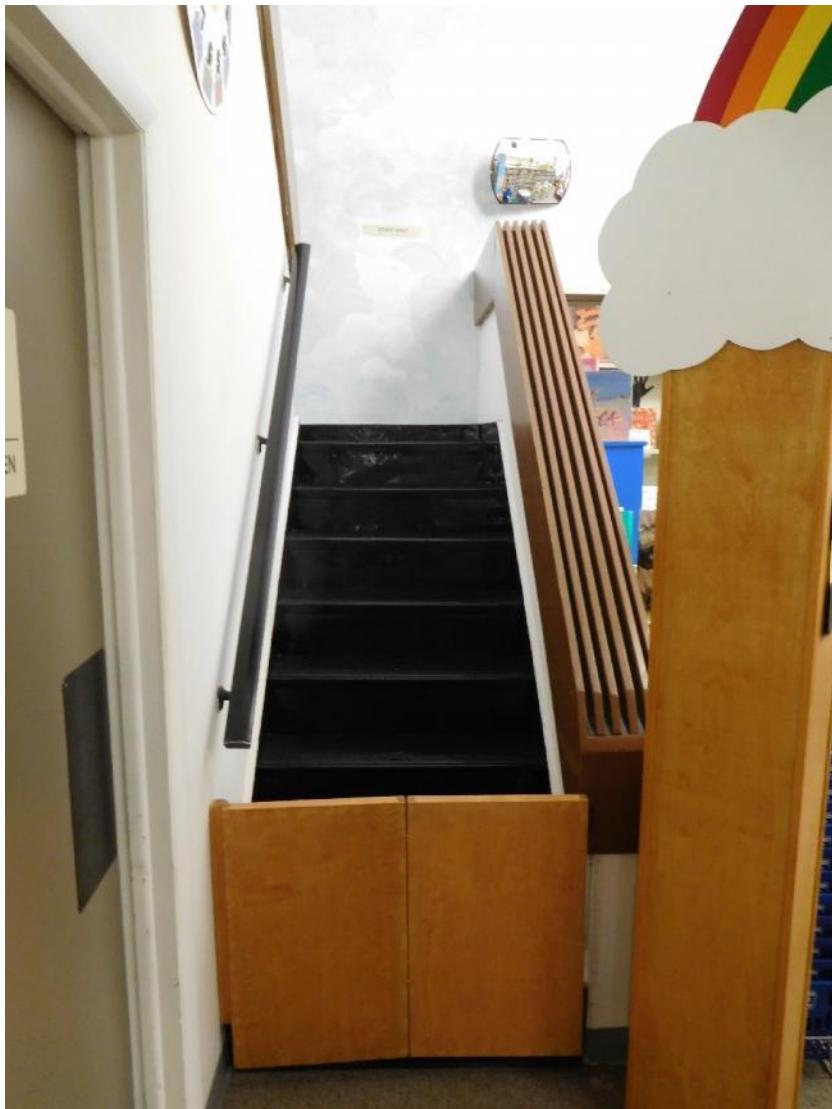
Note handrails and stair landing are not FBC compliant

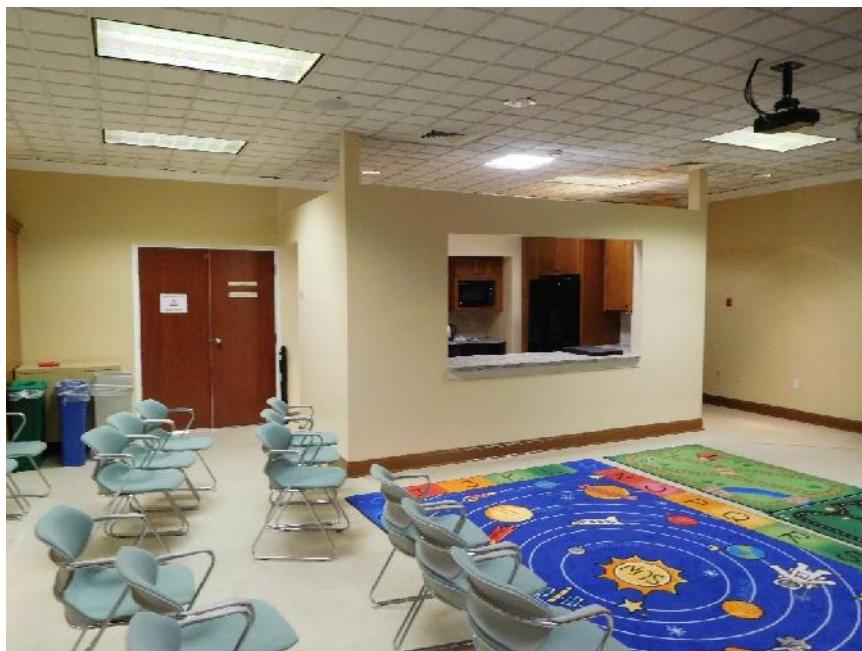
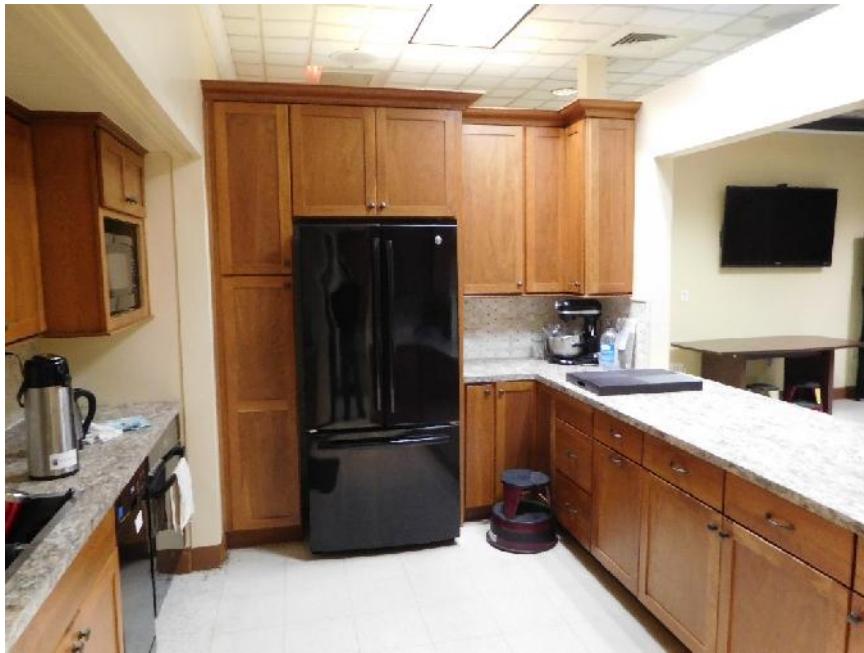
Teaching Kitchen in Community Room

- At the time of previous remodel to add Teaching Kitchen, visual connection to emergency exit sign was compromised. It does not appear that relocation of existing or adding replacement emergency exit signage was provided to address this visual break. Additionally, it does not appear that specific exterior lighting was provided to all exit locations leading to a public way. Without a photometric study this cannot be confirmed.

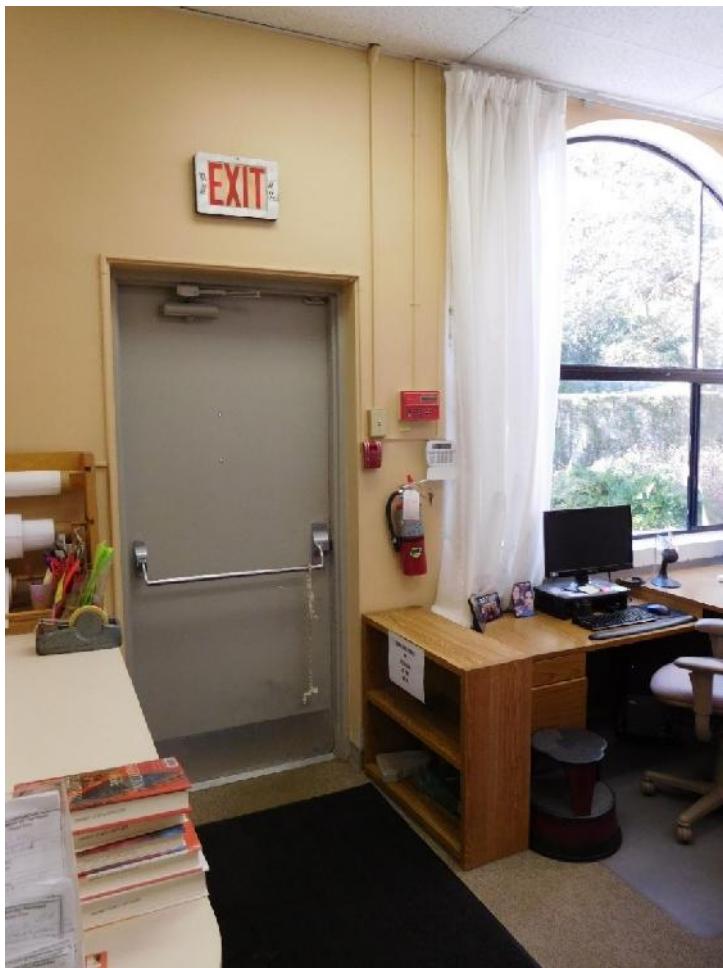
- o Many exposed electrical conduit race ways are surface mounted directly to drywall finishes throughout public spaces such as; light switches, new light fixtures, fire alarm stations, strobes, security alarm control stations, motion sensors etc.

Library Staff Room. Note surface mounted electrical lines.

- o Comprehensive removal and replacement all Acoustical Ceiling Tiles (ACT). At that time replace the surface mounted electrical conduit inside of the ACT system. (It was noted due to the age and obsolescence of the existing square ceiling tiles, upgraded lighting, data and electrical lines were surface mounted to the ceiling system).
- o Consider servicing and updating light fixtures.

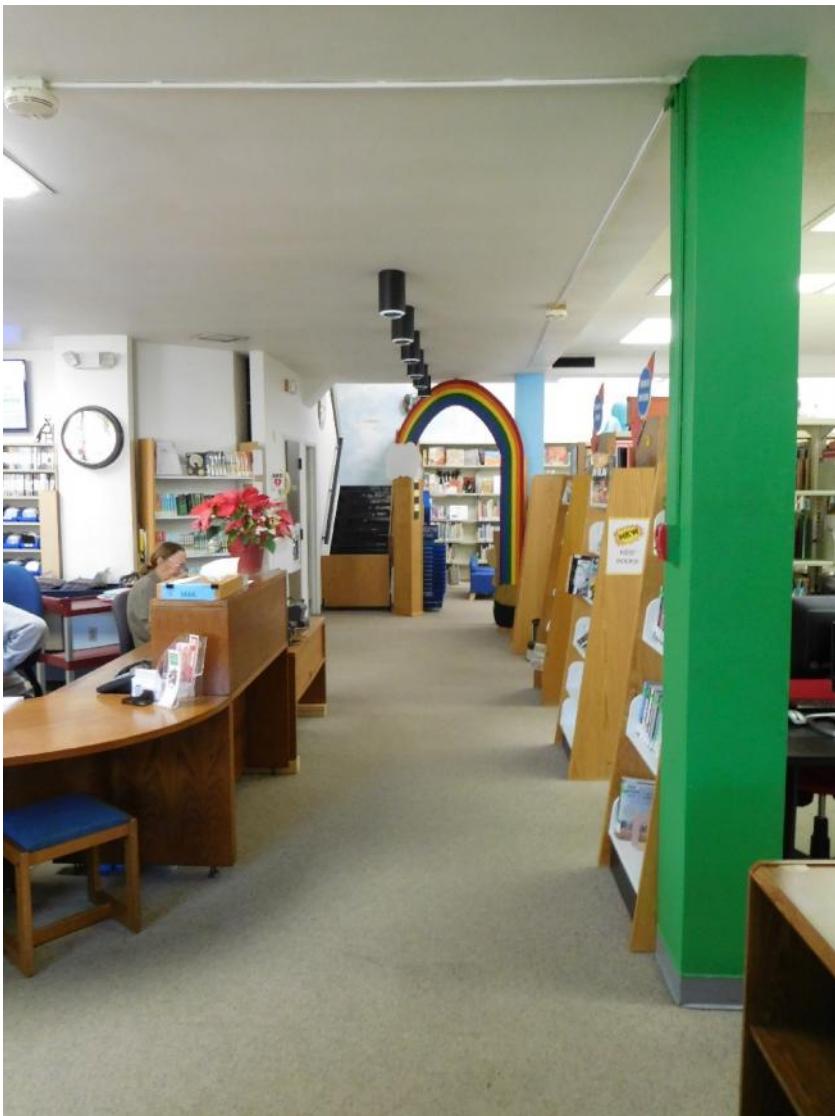
Note exposed electrical conduit in Main Library

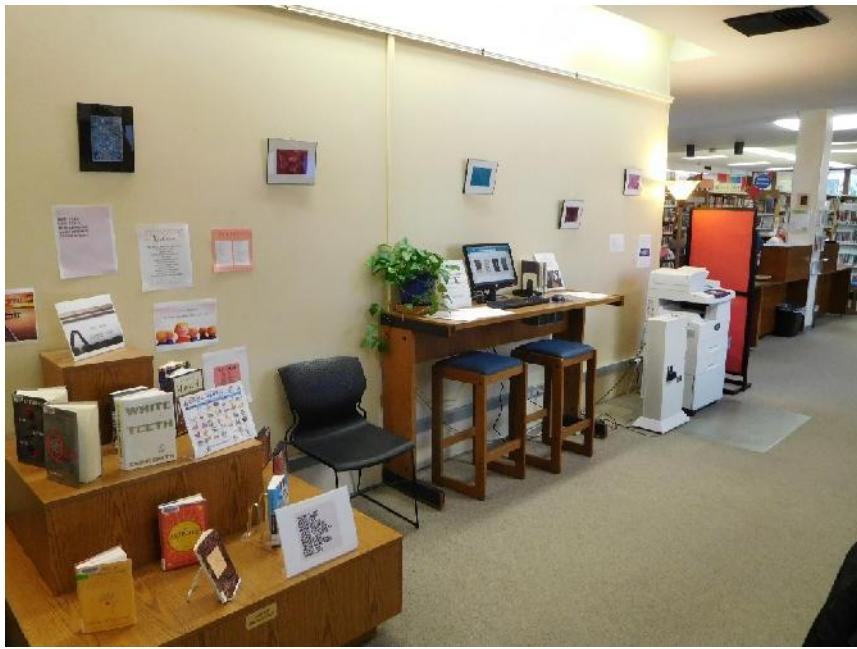
Main Library; Exposed electrical lines.

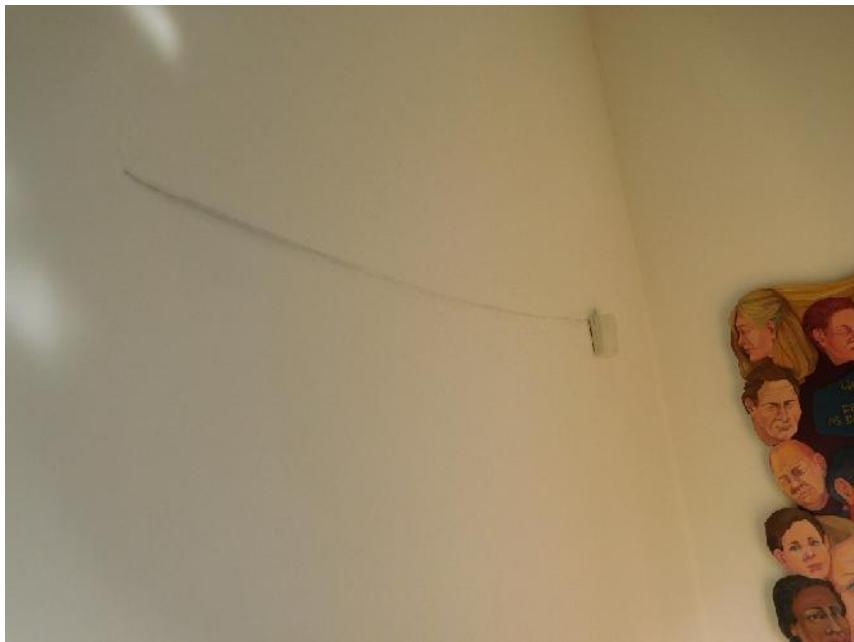
Adult Reading Room; exposed electrical lines

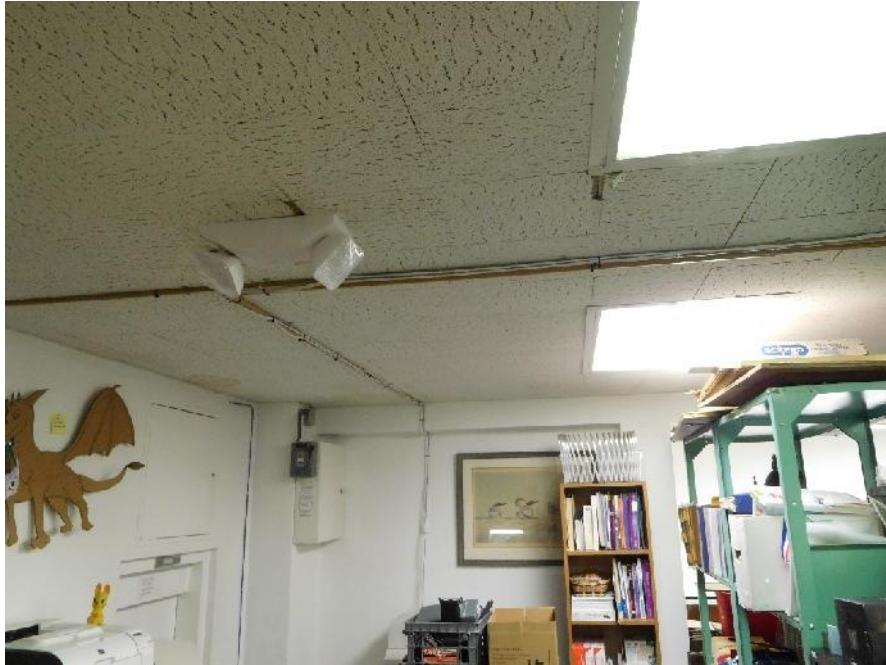
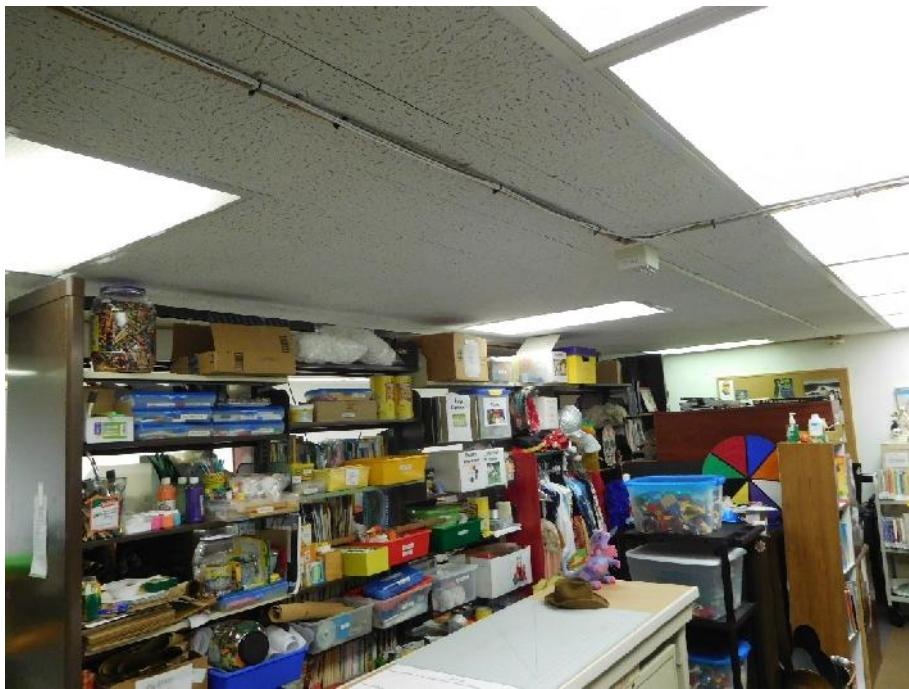
Mezzanine; exposed electrical lines

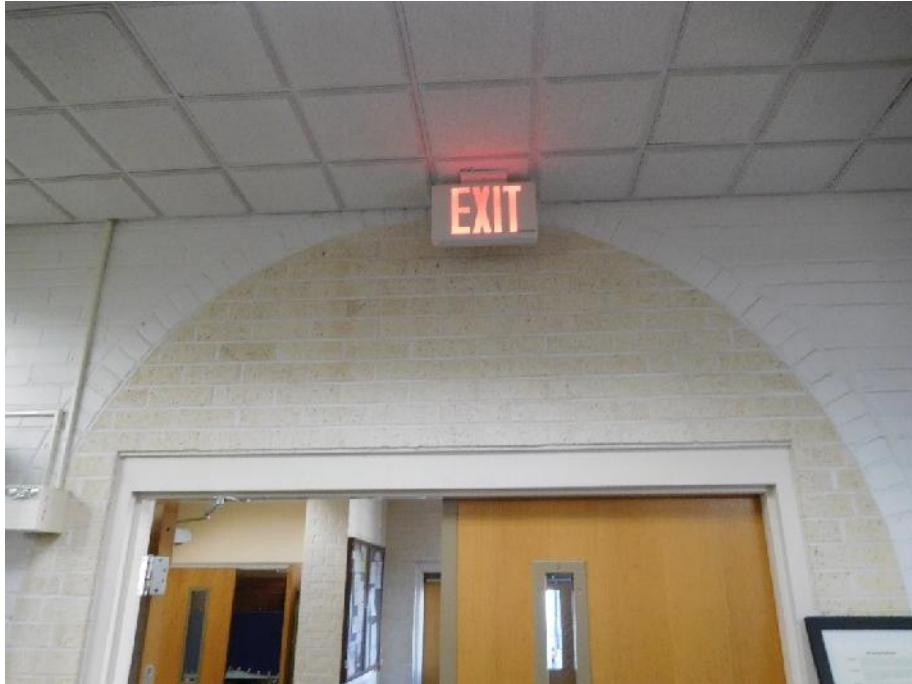
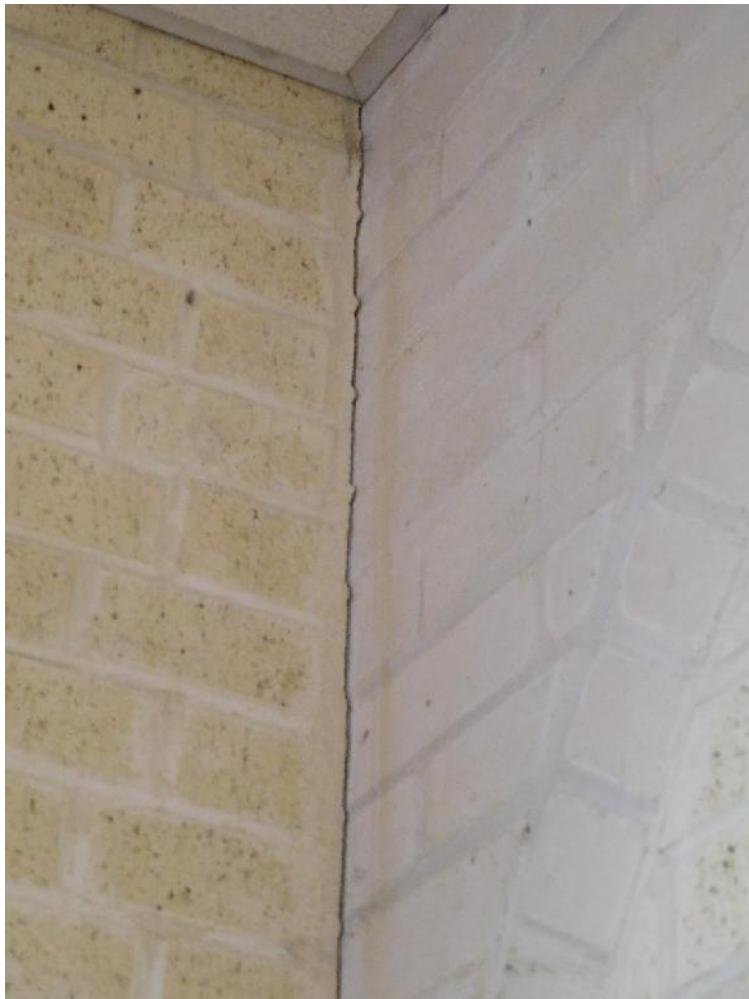
- Areas where brick is the wall system and is exposed, there is a juxtaposition between the original brick and infill brick both in texture and coloring (yellowish to off white) highlighting the construction variation.

Expressed variation of brick type

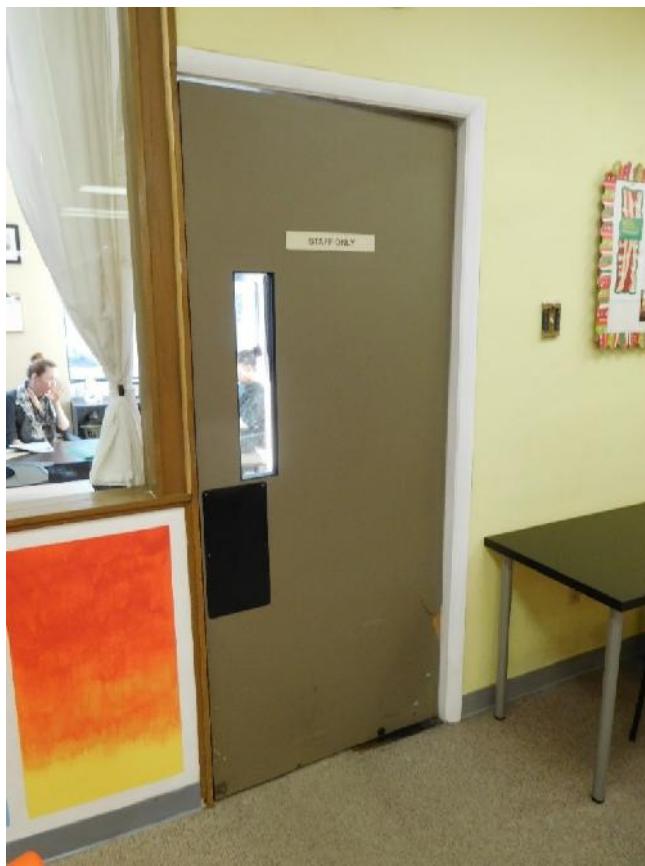
- The most heavily utilized doors are showing signs of excessive wear. Deferring maintenance repair or refurbishment will lead more quickly toward door failure, often ○ these doors and their state of deterioration are publicly visible.

Damaged Staff Room Door

- Conduct building wide door maintenance and refurbishment program to maintain or revitalize existing door assemblies. Include door hardware upgrades such as kick plates, press pads etc., to reduce wear, tear and soiling on doors.
- Remove doors and frames to staff offices and replace with commercial grade wood door and frame assemblies to match existing office.

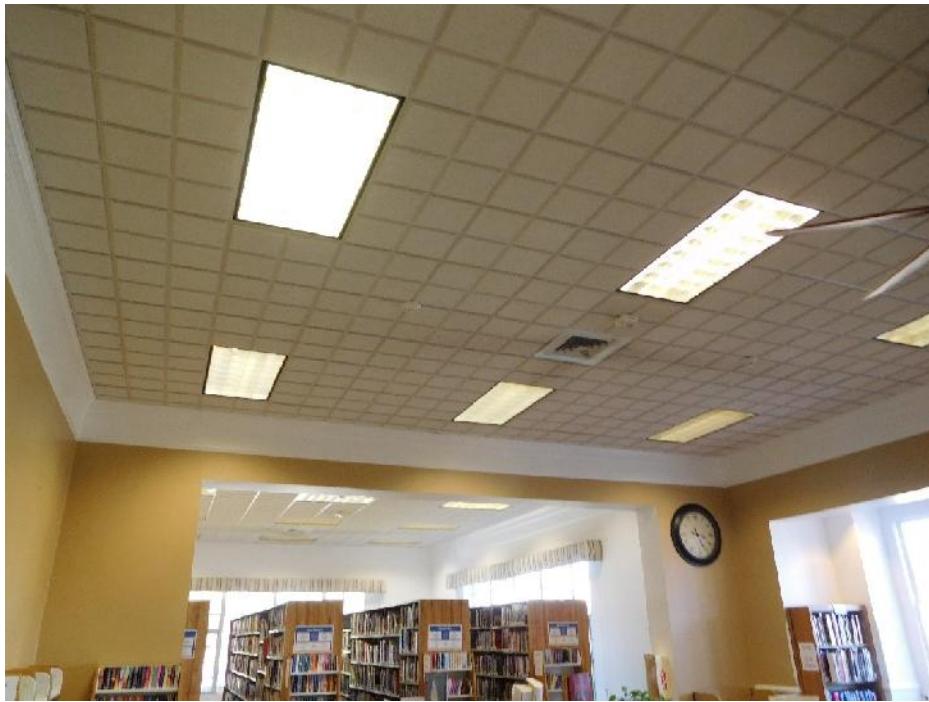
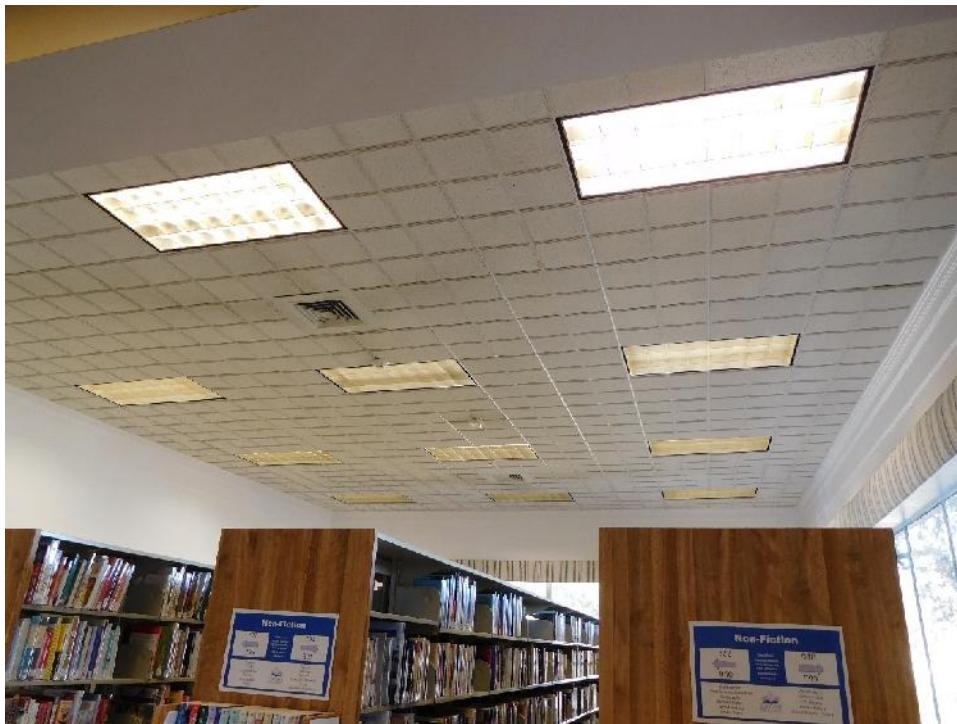
Adult Reading Room ceiling tiles

- Acoustical ceiling tile is in Poor condition most notably due to its service life. There is discoloration, warping, sagging, edge condition deterioration and damaged tiles that have not been replaced. In some areas, missing tiles have either been replaced with dissimilar type and finish, or not been replaced altogether.
- Gypsum board hard ceilings are generally in Good to Fair condition.

- In some areas where damaged tiles have been removed, they have either been replaced with dissimilar type and finish, or not been replaced altogether. Both these conditions occur within public observation areas.

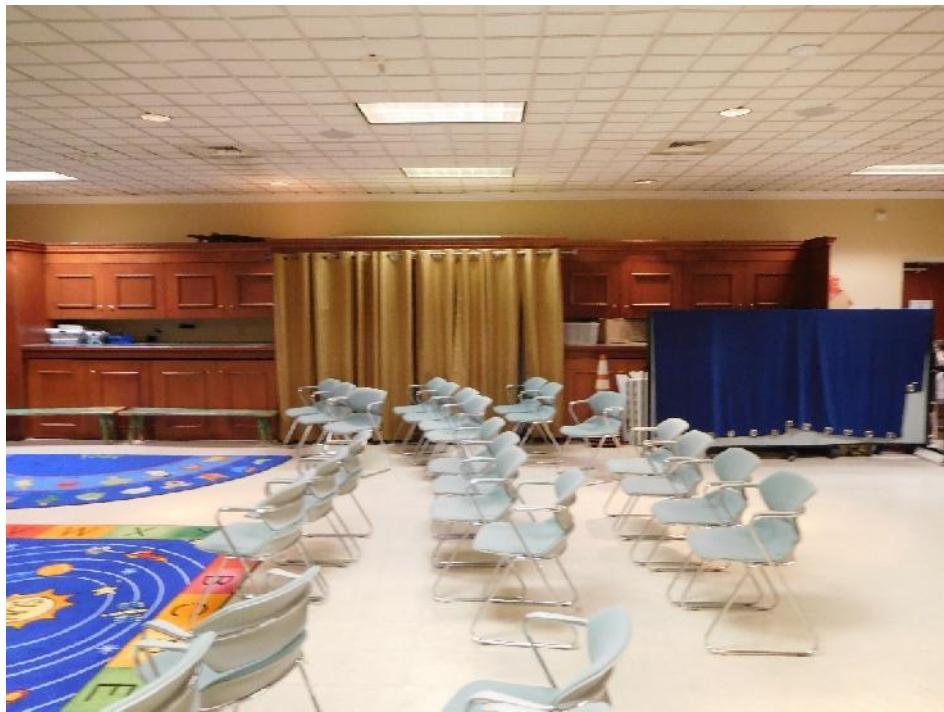
Community Room flooring

-]) General Conditions
 - The general condition for both the carpeting and vinyl tile is in Good condition.
-]) Concerns
 - The Community Room is a highly used public area and is showing signs of heavy use. This area needs periodic maintenance to floor; stripping, cleaning, re-waxing and buffing.

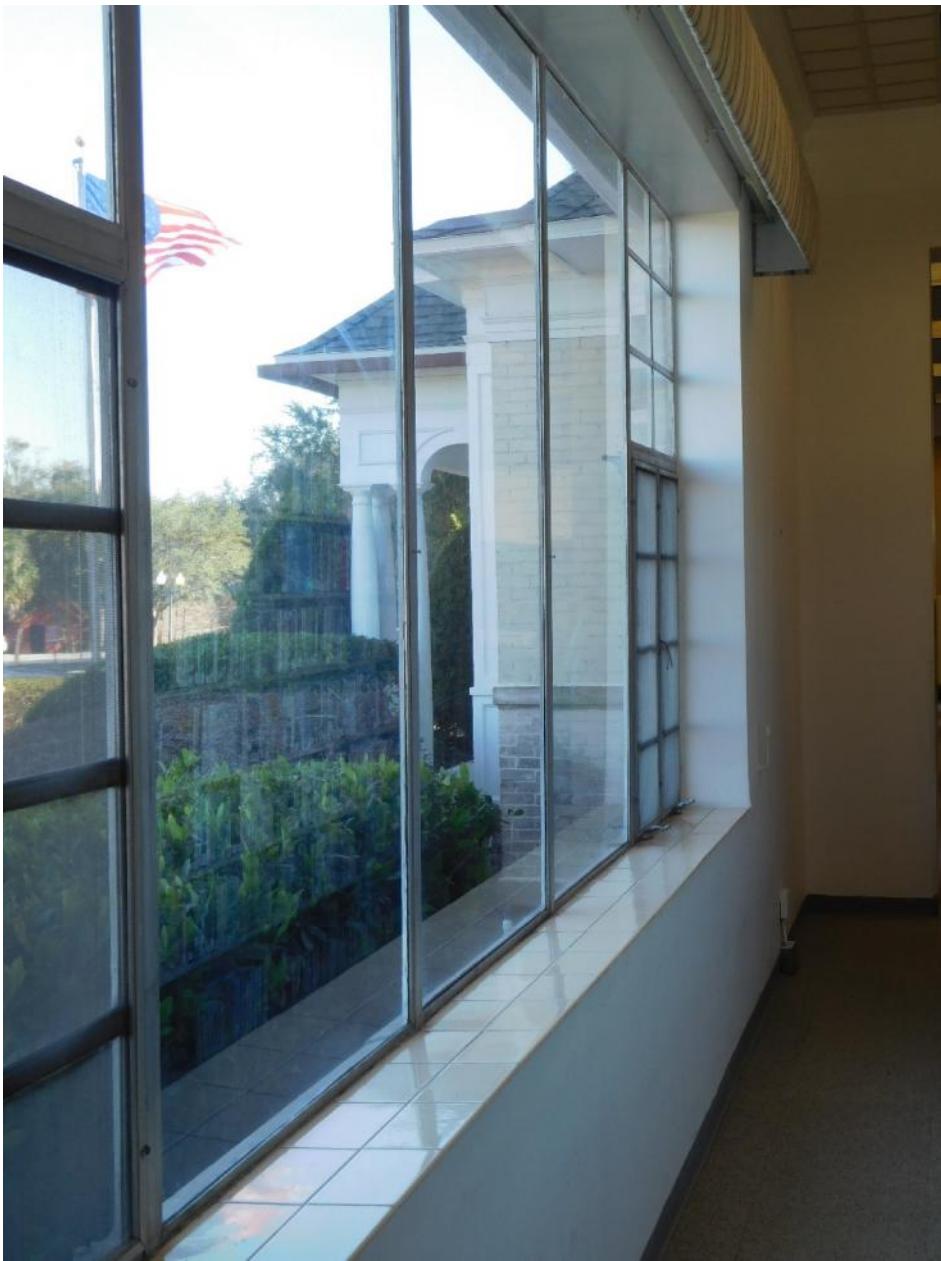
Reading Room window

- o Original building wood frame windows in the Adult Reading Room have signs of water intrusion above the interior window head, jamb wall return and sill.
- o The single pane aluminum windows along the 1959 wing addition show signs of water damage and intrusion along the window jamb.

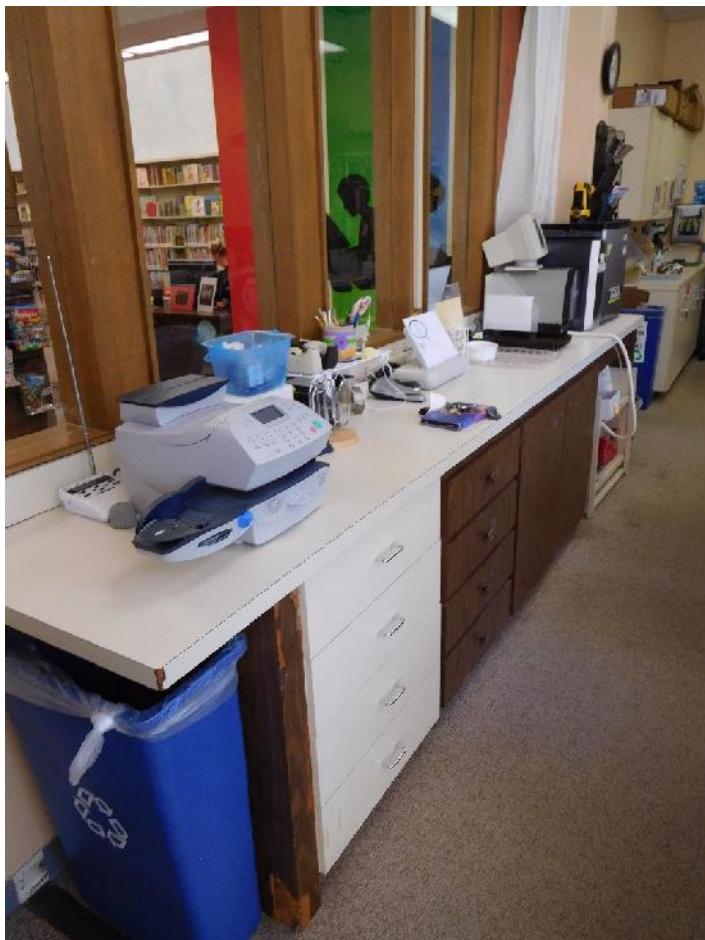
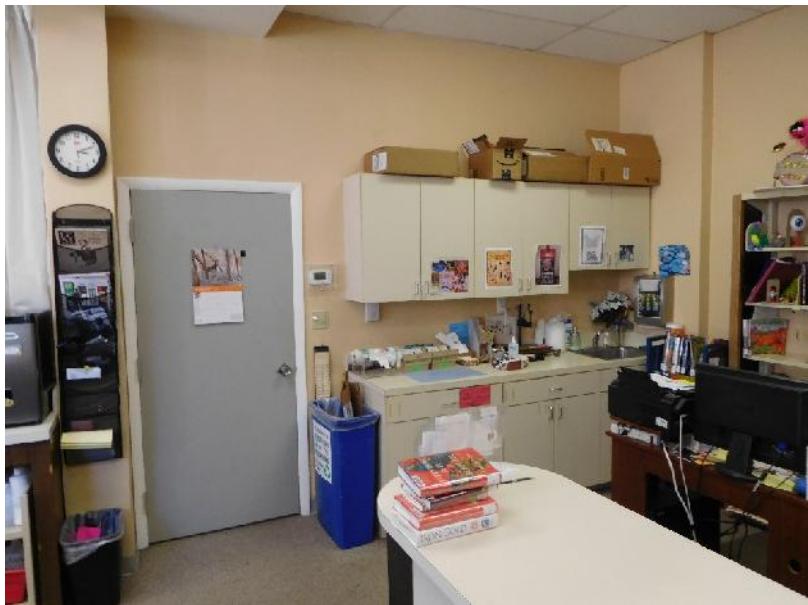
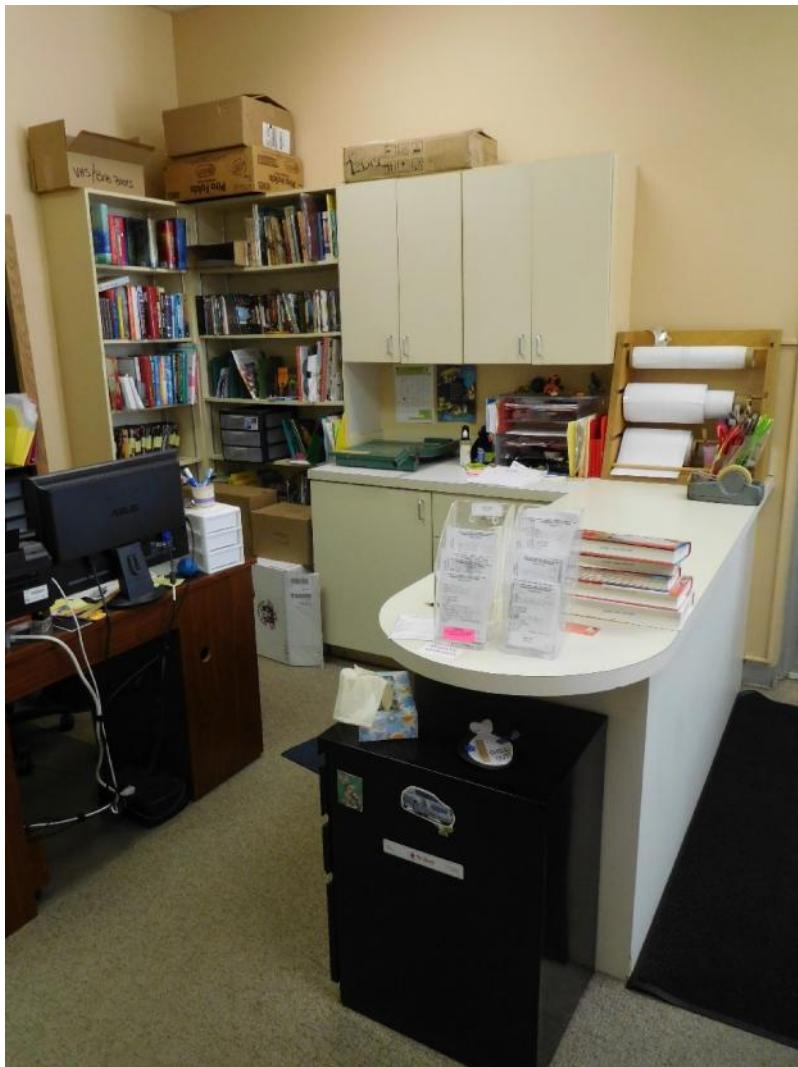
Staff Room Millwork

- With both the millwork and casework; their types and finishes are widely varied and reflect widely differing aesthetic additions to the facility. As such, there is an ad hoc appearance that creates a clashing aesthetic language particularly where conflicting systems are utilized in close vicinity.

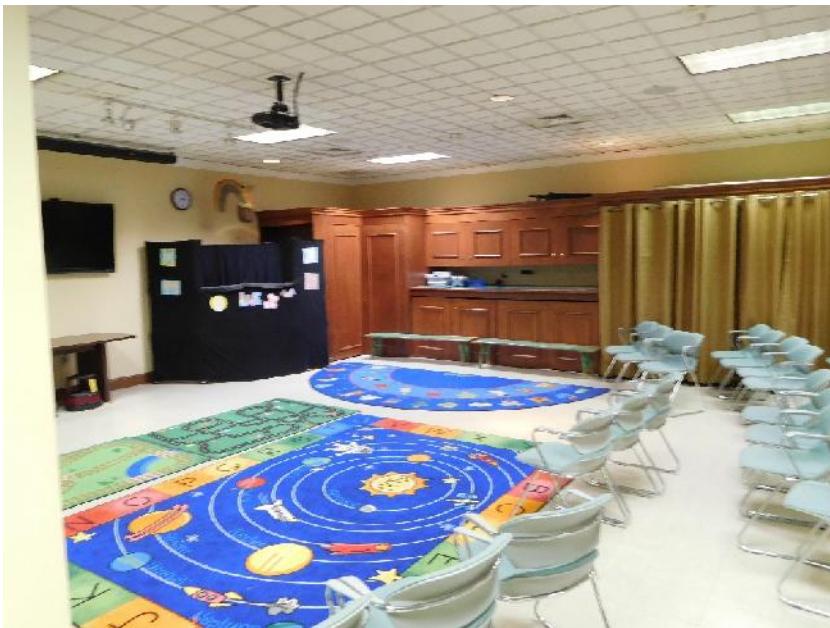
Meeting Room Storage

While being in Good condition and high appearance value, have construction and detailing is of a light duty residential nature. There does not appear to be adequate lateral bracing, and particle board fabrications do not lend itself to high utilization, wear or service life. This installation also does not appear to have been programmed into the space utilization or storage needs, but it was something added and incorporated into use; the utilization of curtains as a system enclosure would unify that space.

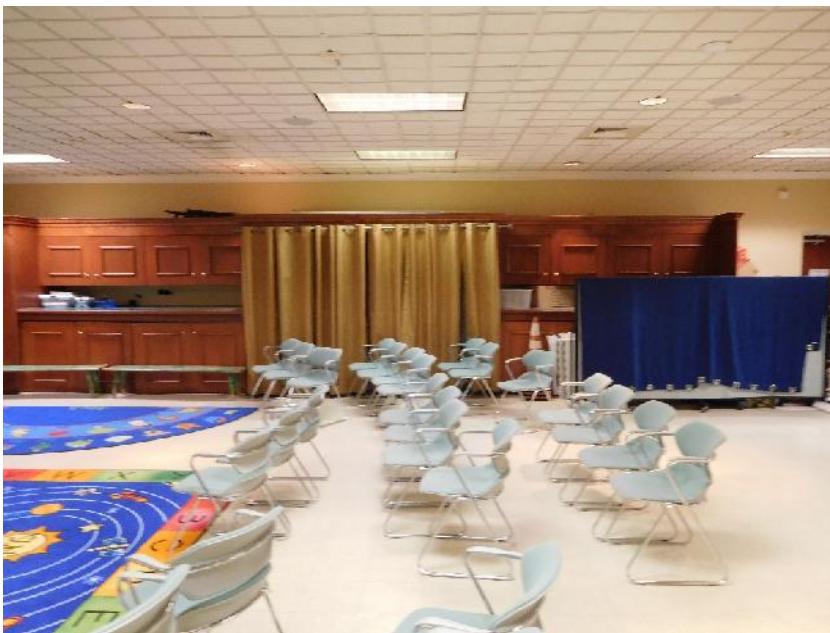
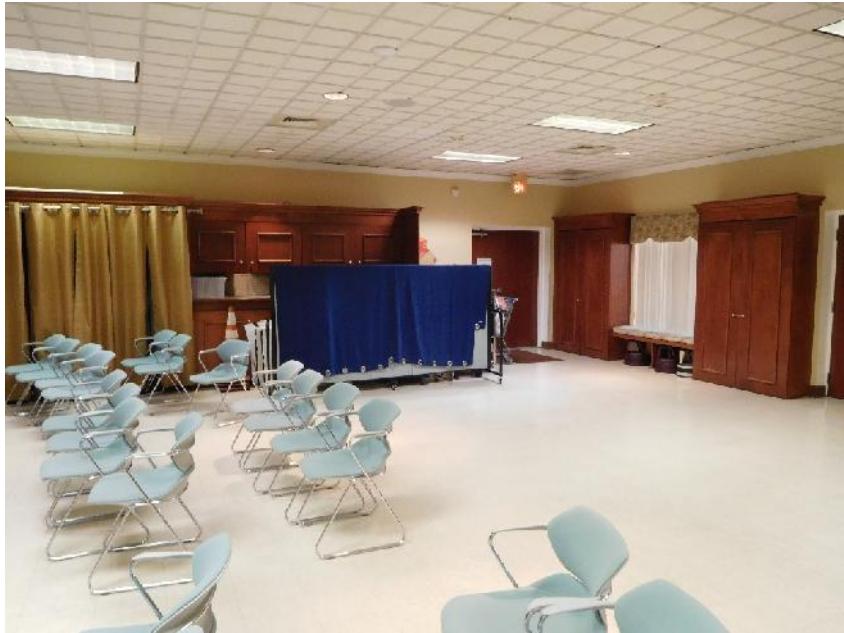
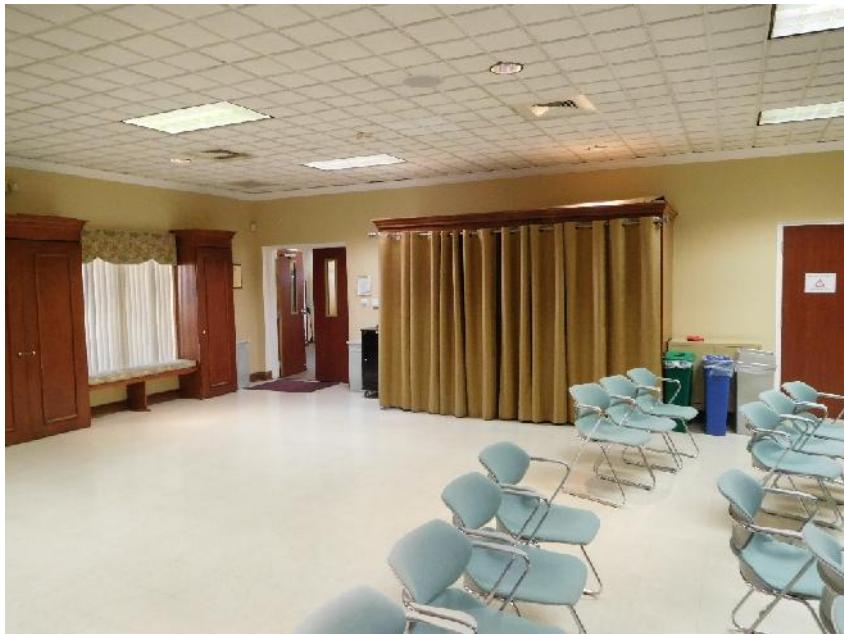
Meeting Room Storage

- Undergo a programmatic storage assessment for the library's needs, with concentrated focus on the Multi-Purpose Community Room. Remove and replace existing storage units (residential type) with commercial millwork targeted to address the programmatic needs of the service program.

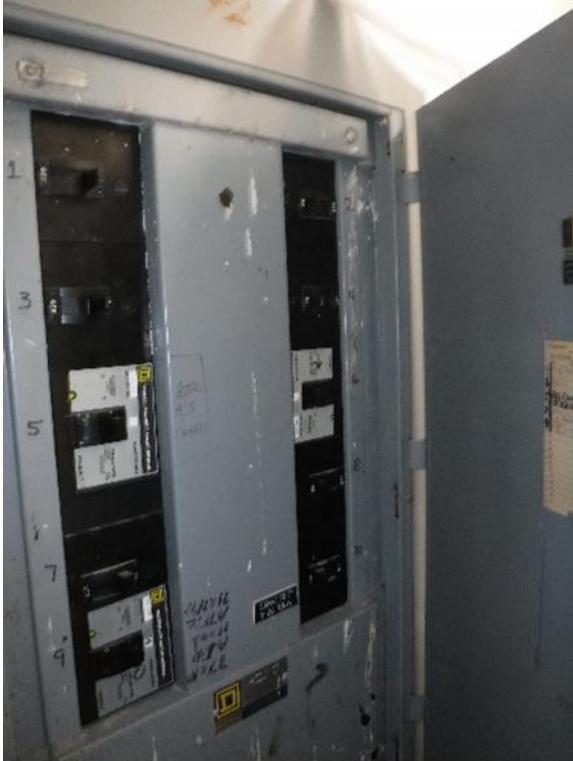
The existing main distribution panel is in the Janitor's Closet behind the Service Desk area. The panel is a Square D I-Line, 600 amp, 208Y/120V, 3 phase, main lug only with no spaces or spares and appears to be in good condition.

Main Distribution Panel

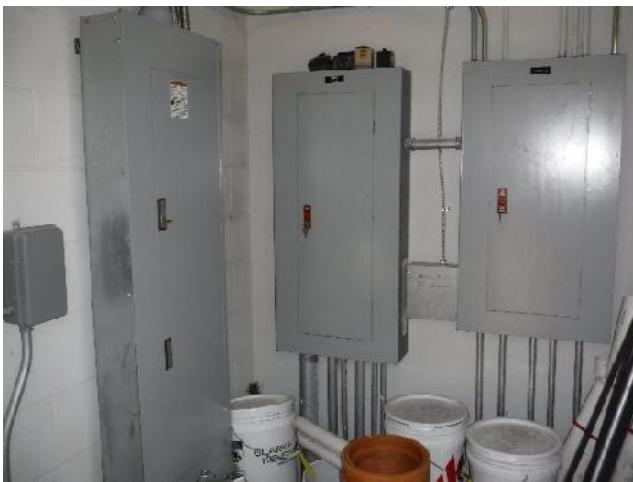
The existing main Electrical Room is on the West side of the building. There are (3) distribution panels in the room which appear to be in excellent condition. The panel on the left was added to provide power for Kitchen equipment and is an Eaton PRL1a panel, 225 amp, 208Y/120V, 3 phase, 42 circuit with a 200 amp main breaker. The panel has 29 spaces.

Main Electrical Room Distribution Panels

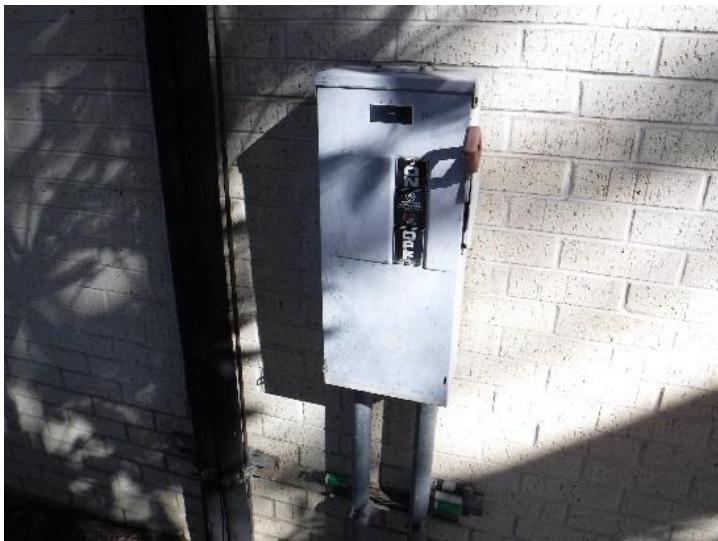
Exterior Disconnect Switch

All interior and exterior disconnect switches for mechanical equipment appear to be in good condition.
