The City of Maitland Library: Facilities Assessment Report

BORRELLI + PARTNERS

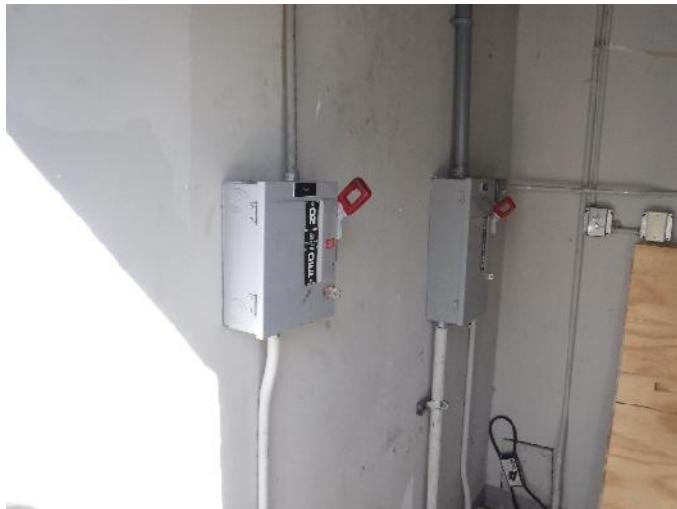
All interior and exterior disconnect switches for mechanical equipment appear to be in good condition.

Interior Disconnect Switches

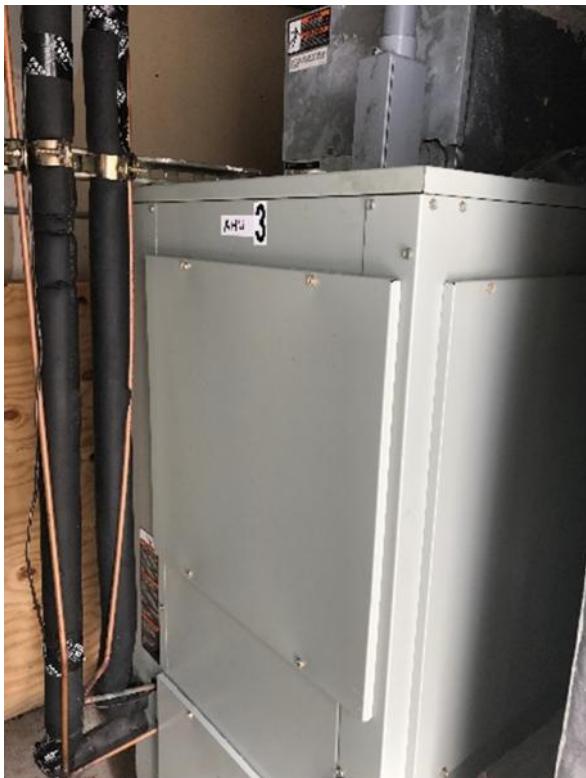
The Multipurpose room is approximately 2,900 square feet in size. This room is served by a single 10-ton air handling unit (AHU-3) located in a 1st floor mechanical room adjacent to the Multipurpose room. This AHU is coupled with a single dual compressor, air cooled condensing unit (CU-3) located on the west side of the building. This condensing unit is located near the driveway and is protected by 3 bollards. This equipment is in excellent condition and is only 15 months old. Since the unit is served by a condensing unit with dual compressors, it has the ability to stage down to about 50% of its maximum capacity. This is beneficial since the space is often empty and does not always need 10 tons of cooling. This unit has an electric resistance heater rated at 26.2 KW.

10 Ton Air Handling Unit (AHU-3)

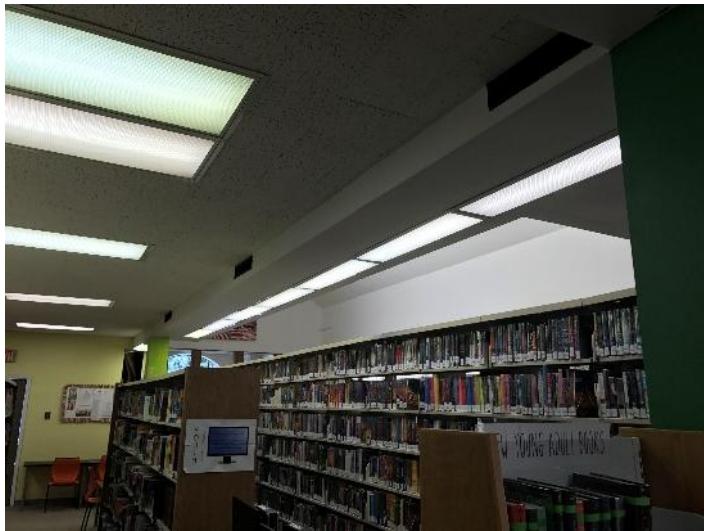
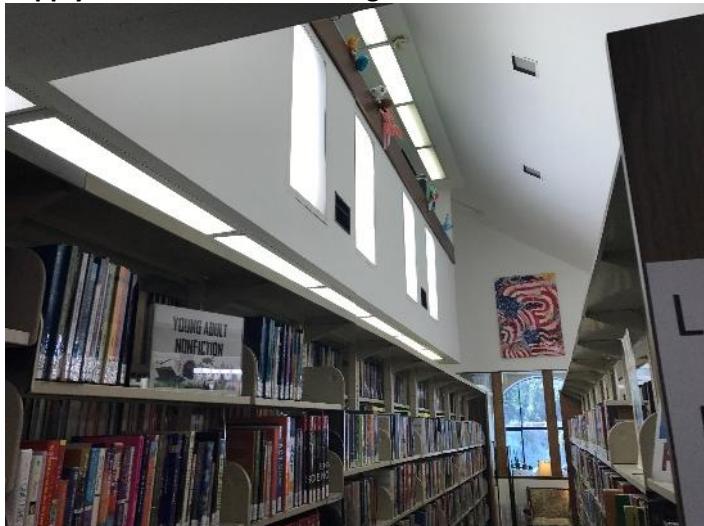
The ceiling diffusers consist of ten 2'x2' lay in ceiling diffusers in the acoustical ceiling grid. The diffusers look old and this particular type of ceiling diffuser does an average job of distributing the air.

Supply Air Diffusers at Reading Room

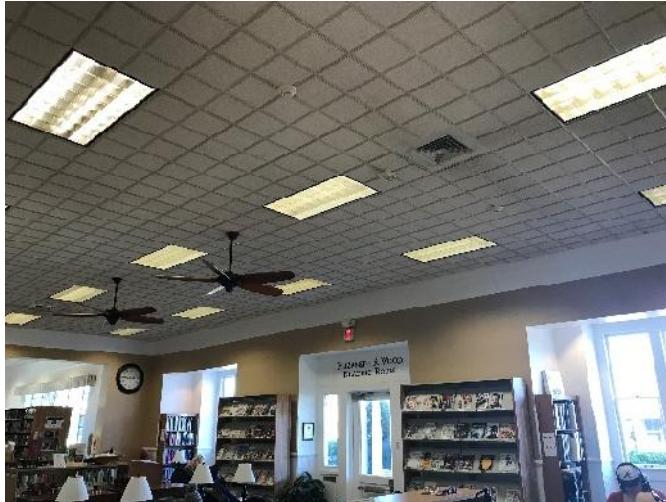
The ceiling diffusers consists of (4) four 2'x2' lay in ceiling diffusers located in the acoustical ceiling grid. The diffusers look old and this particular type of ceiling diffuser does an average to poor job of distributing the air.

Supply Air Diffusers at Reading Room

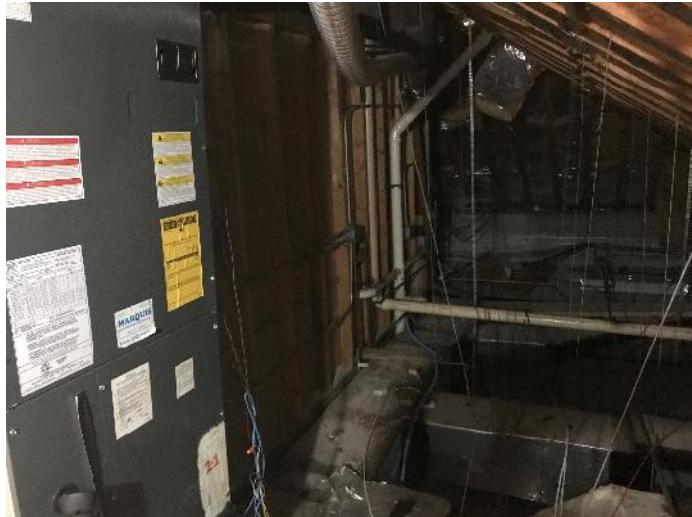
3.5 Ton Air Handling Unit (AHU-2.1)

- Equipment Replacement: We recommend that consideration be given to replacing the existing the two R-22 systems which serve the 2nd floor reading stacks and the west offices. These units are old and inefficient, and the R-22 refrigerant is very expensive to purchase in case there is a leak. The replacement units will be much more energy efficient.

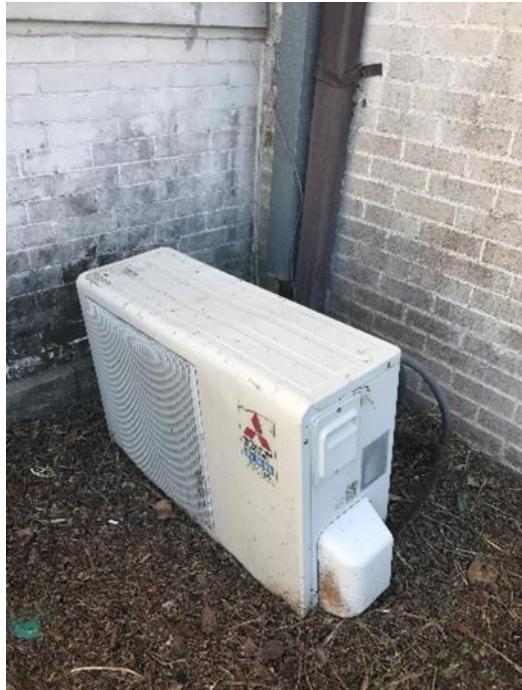
This room is served by a dedicated 1.0-ton Mitsubishi mini split AC system. The condensing unit serving this area is located on the Northeast side of the building in an exterior corner of the building near the entrance to the Library.

1.0 Ton Condensing Unit

- Consider relocating the (2) two air handling units serving the East Reading Stacks to a ground mounted vertical configuration. These units are difficult to access and service in their current location.
- Consider replacing the 1.0-ton AC system with a new more efficient AC system of similar configuration. The existing system appears to be 7-10 years old and will eventually need to be replaced.
- Consider replacing the ceiling mounted supply air diffusers throughout the facility with better performing ceiling diffusers which will also improve the aesthetics in the spaces.
- Central HVAC Controls: We recommend that a basic rudimentary control system be installed that would allow the user to monitor and control temperatures and AC equipment status from a single location. This system could consist of several Webstats which would allow interface and monitoring through the internet.

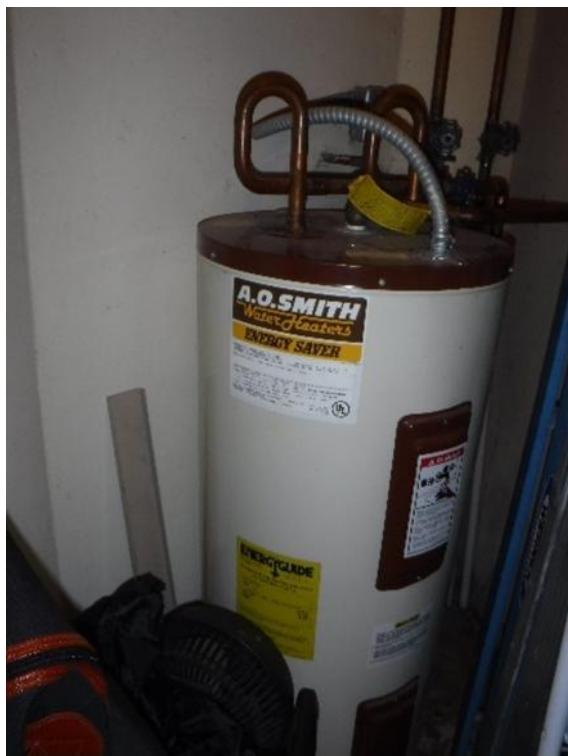
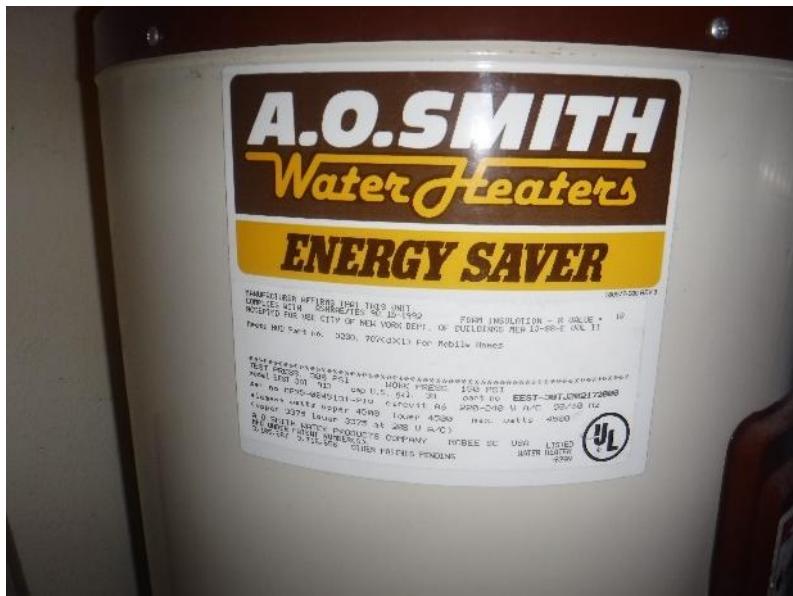
There is a 30 gallon tank type water heater in the first floor storage closet. This water heater serves the two first floor restrooms by the checkout desk and the 2nd floor employee lounge and restroom. This water heater appears to be several years old and in good working condition.

30 Gallon Tank Type Water Heater

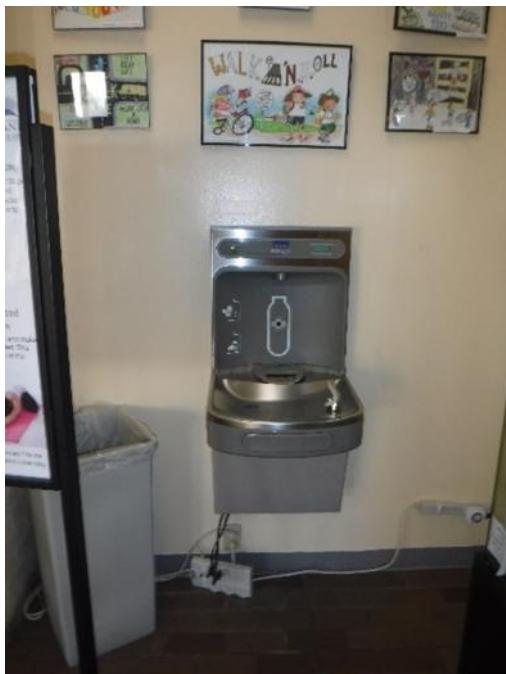
There is an electric water cooler in the Lobby. This water cooler appears to be fairly new and in very good condition.

Lobby Electric Water Cooler

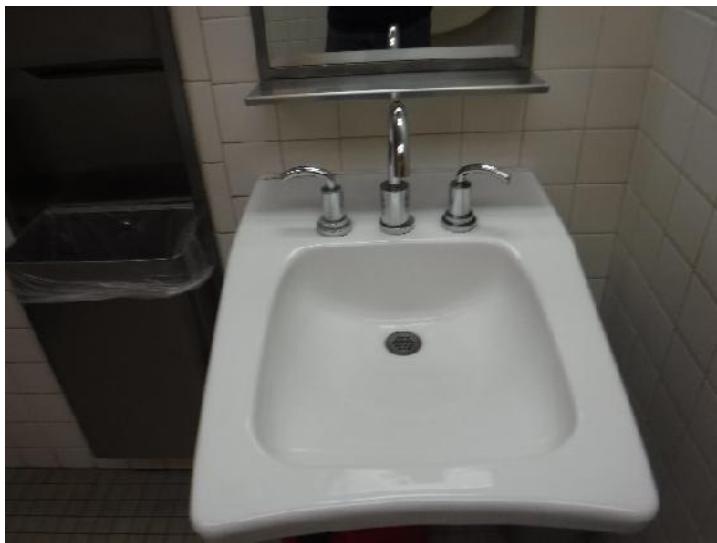
The plumbing fixtures in the lobby restrooms consist of manual flush valve wall hung water closets, a manual flush valve urinal and wall hung lavatories. These plumbing fixtures appear to be fairly new and in excellent condition.

Lobby Women's Restroom Lavatory

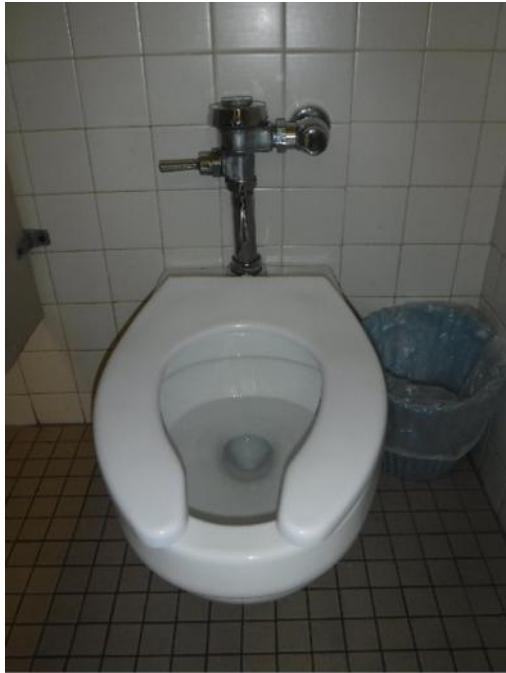
Lobby Women's Restroom Water Closet

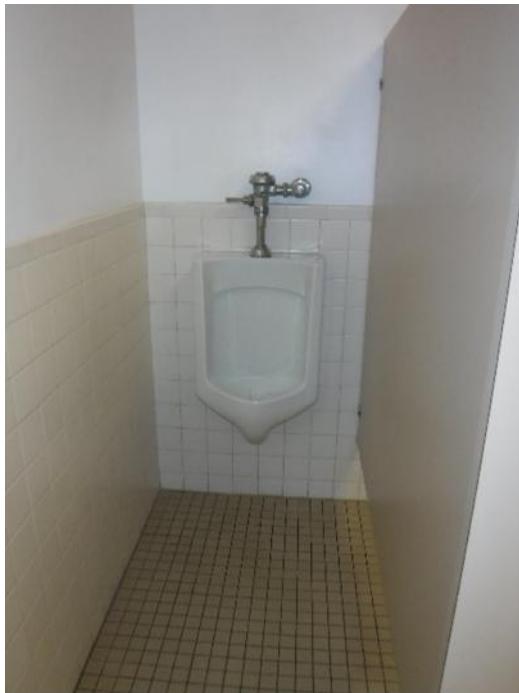
Lobby Men's Restroom Urinal

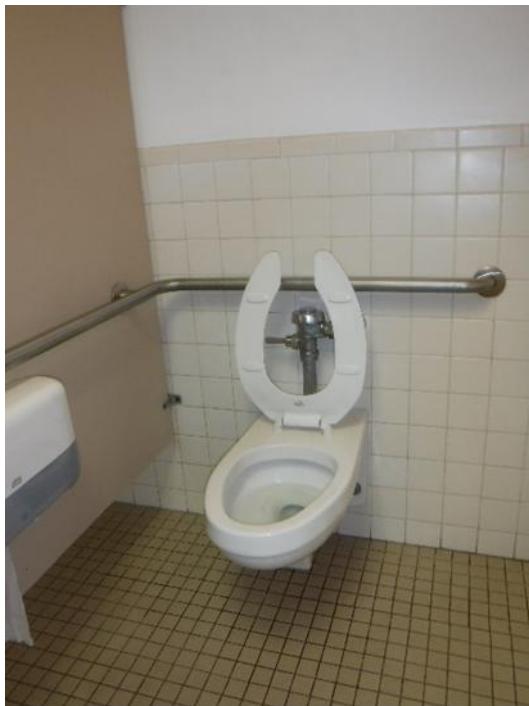
Lobby Men's Restroom Water Closet

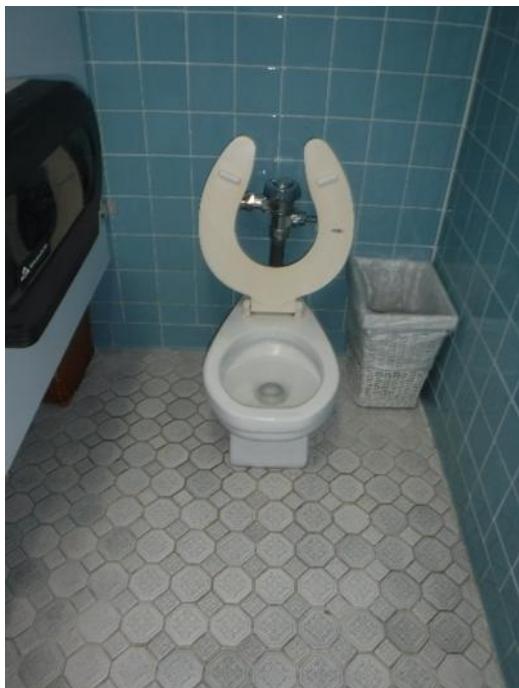
The plumbing fixtures in the 1st floor restrooms consist of manual flush valve water closets, a floor mounted manual flush valve urinal, counter mounted lavatories and a mop sink in the men's restroom area. These plumbing fixtures are older and appear to be in good working condition.

1st Floor Women's Restroom Children's Water Closet

- o As plumbing fixtures are replaced, we recommend replacing with water conserving 1.28 GPF water closets, water conserving 1/8 GPF urinals and water conserving .50 GPM flow faucets.

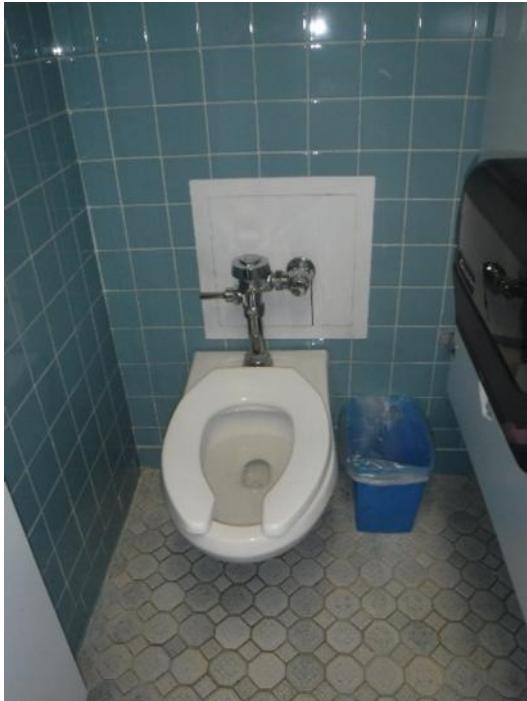
1st Floor Women's Restroom

Water Closet

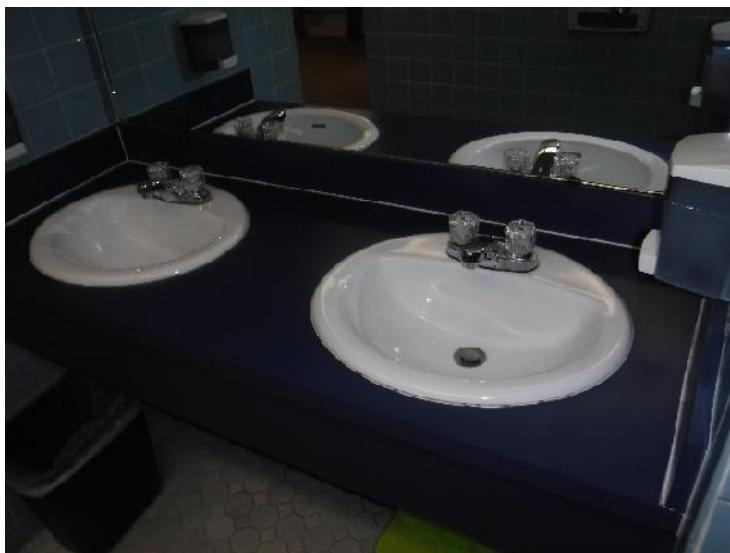
1st Floor Women's Restroom Lavatories

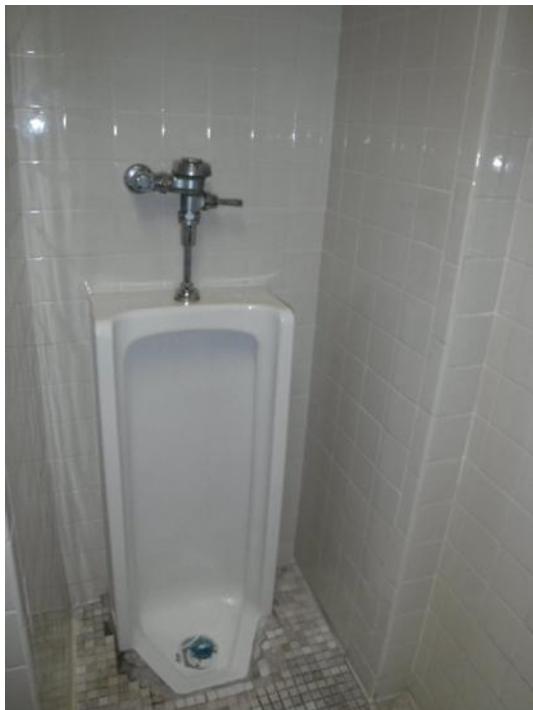
1st Floor Men's Restroom Urinal

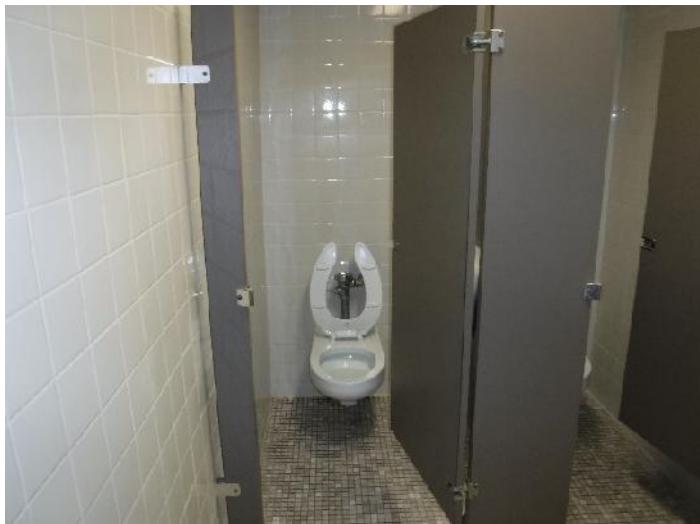
1st Floor Men's Restroom Water Closet

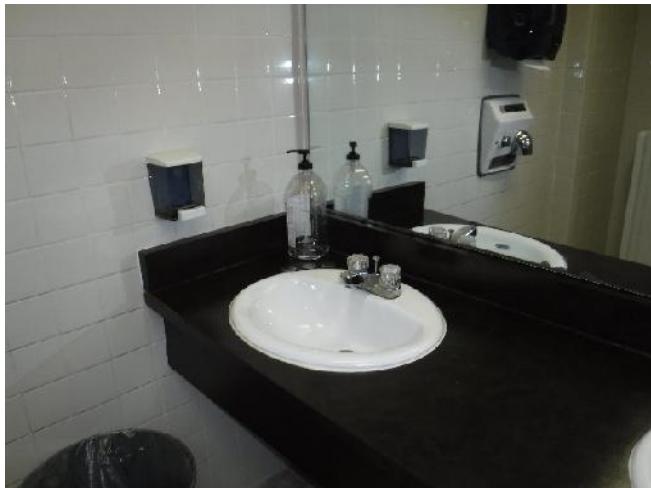
1st Floor Men's Restroom Lavatories

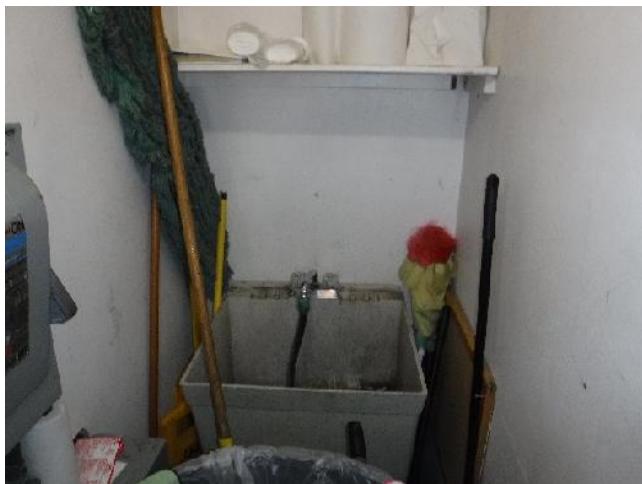
1st Floor Restrooms Mop Sink

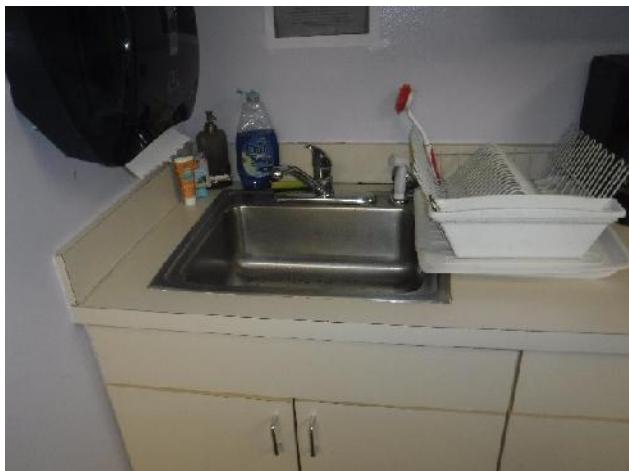
The plumbing fixtures in the 2nd floor Employee Lounge and Restroom consist of a counter sink in the lounge, a tank type water closet and counter mounted lavatory in the restroom. These plumbing fixtures are older and appear to be in good working condition.

Employee Lounge Counter Sink

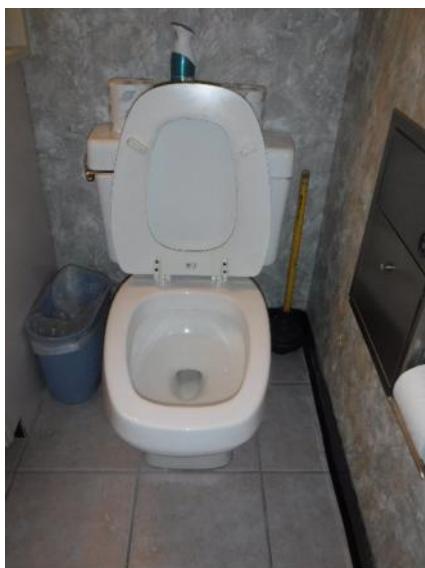
Employee Lounge RR Water Closet

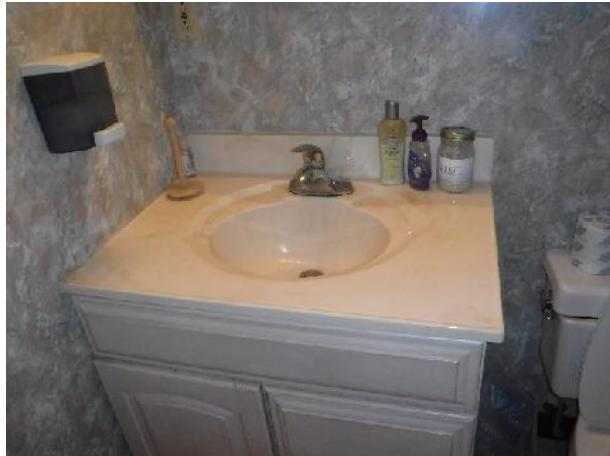
Employee Lounge RR Counter Mounted Lavatory

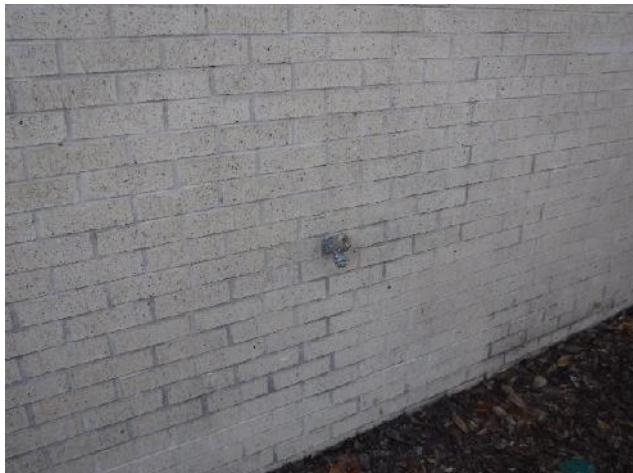
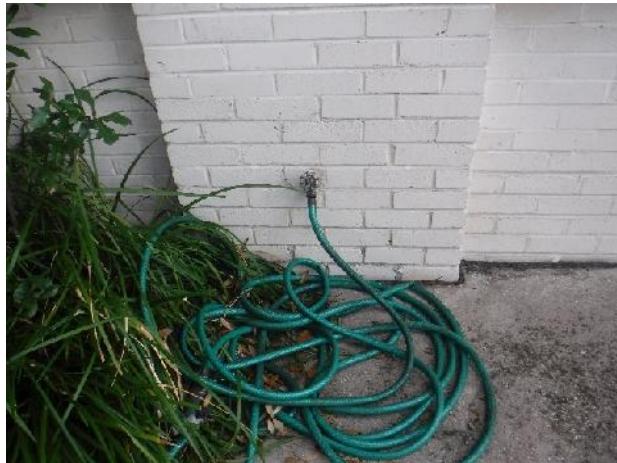
There are (2) exterior wall mounted hose bibbs. These hose bibbs appear to be in good working condition with no evidence of leaks.

Exterior Wall Mounted Hose Bibb
